MEMORANDUM

DATE: September 9, 2022

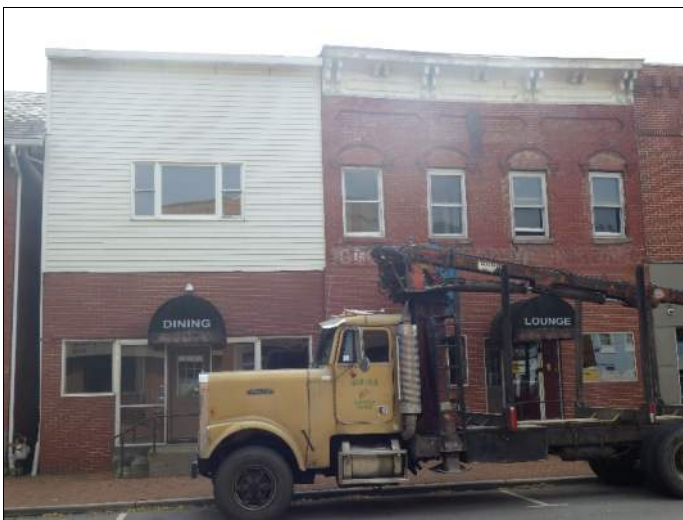
- Replace damaged vinyl siding.
- Replace T1-11 siding, preferably with vinyl to match adjacent siding, and replace deteriorated trim.
- Replace awning above storefronts.
- Repair and refinish wood-framed windows and install wood-framed storm windows.
- Replace wood door to second story.
- Add threshold at second-story door.
- Repair or reconstruct sagging cornice.

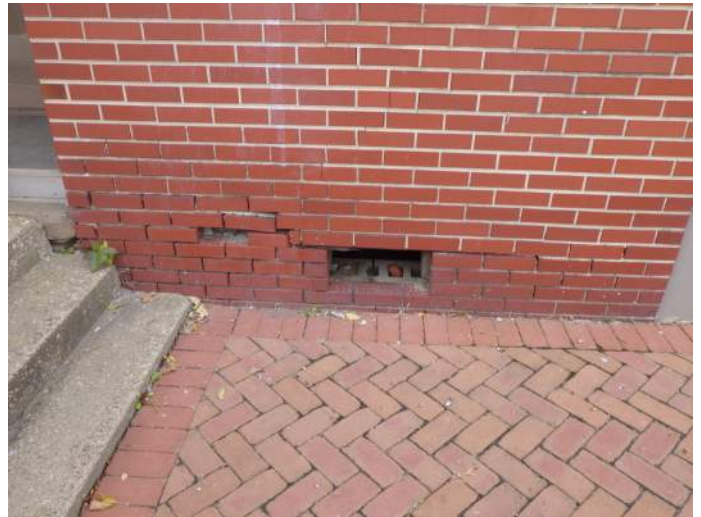
Deteriorated brick veneer and mortar

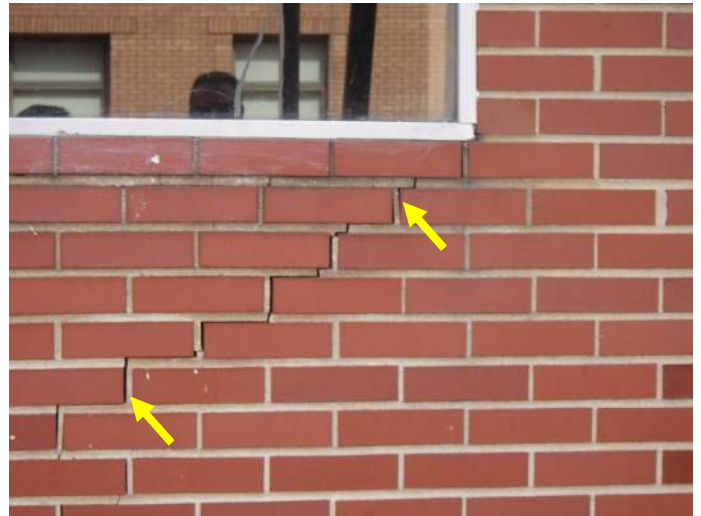
Incompatible mortar around window

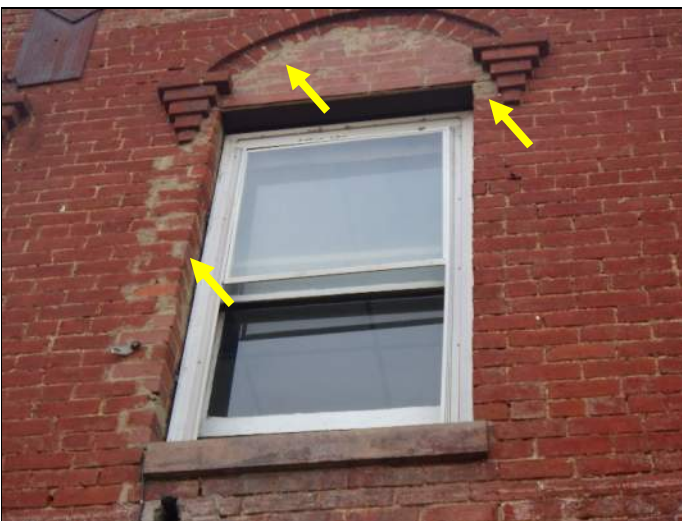
Stair step cracks in brick veneer

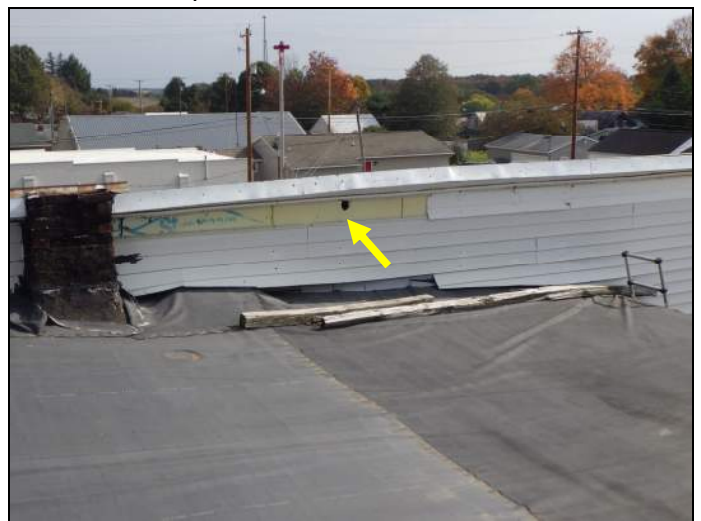
Missing vinyl siding

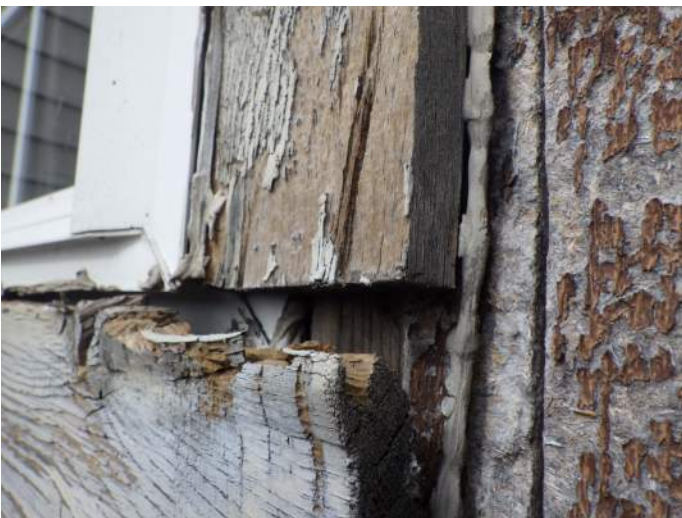
Deteriorated wood trim

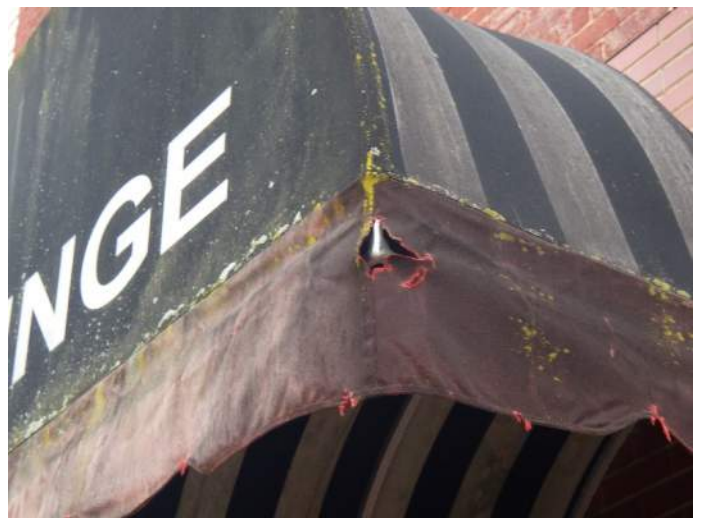
Deteriorated storefront awning

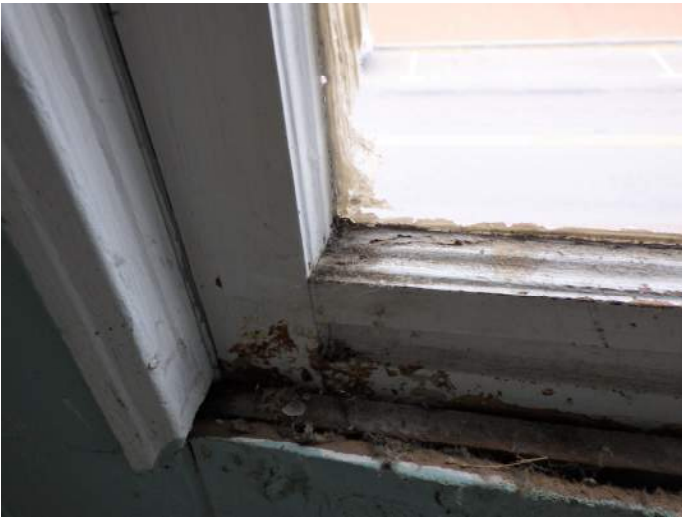
Typical window condition

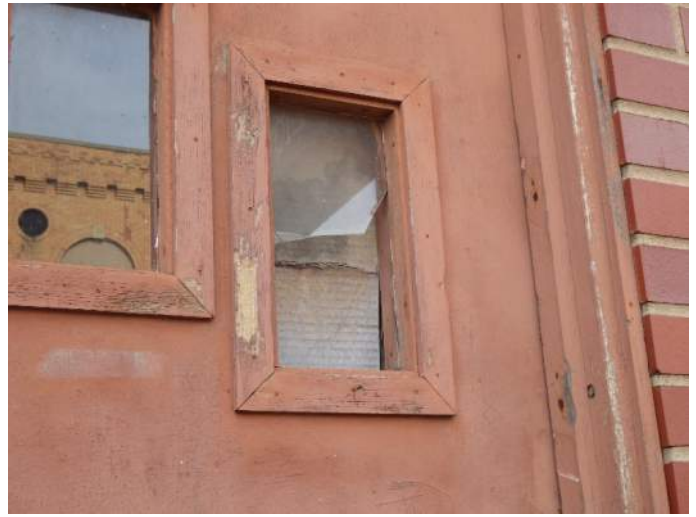
Broken window in wood door

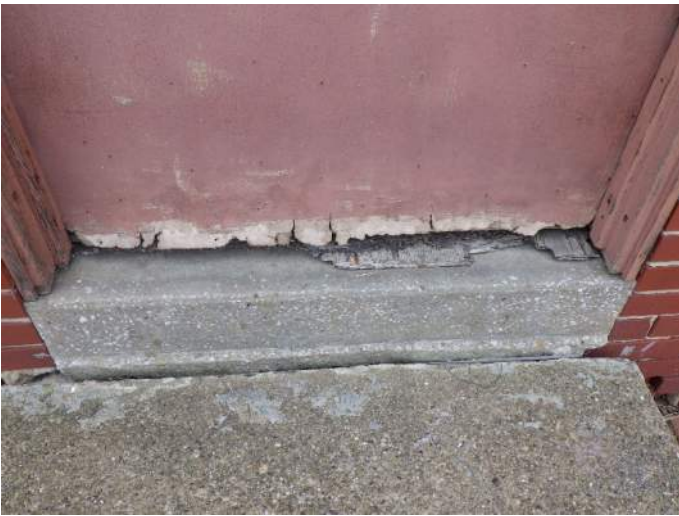
Delaminating wood door

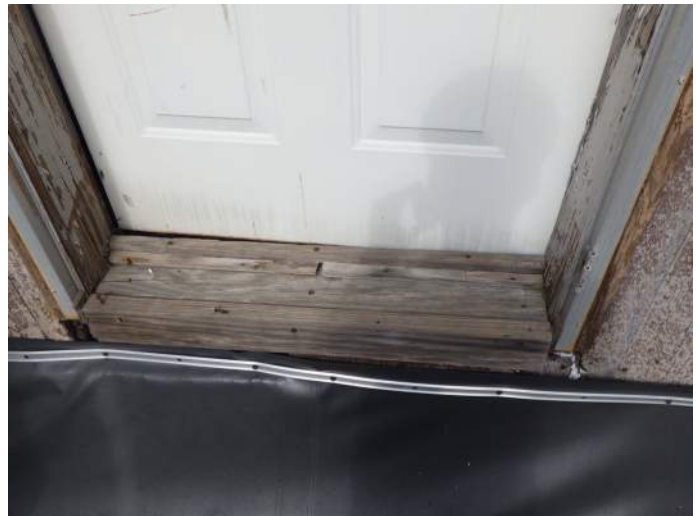
Missing threshold at second-story door

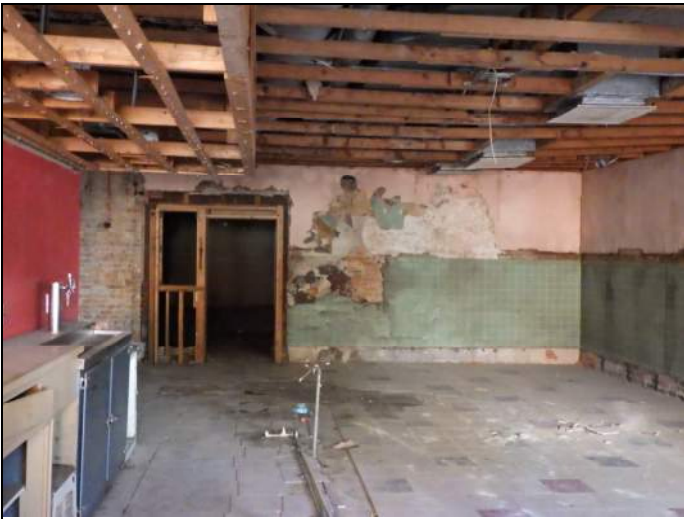
Overview of first story of west building

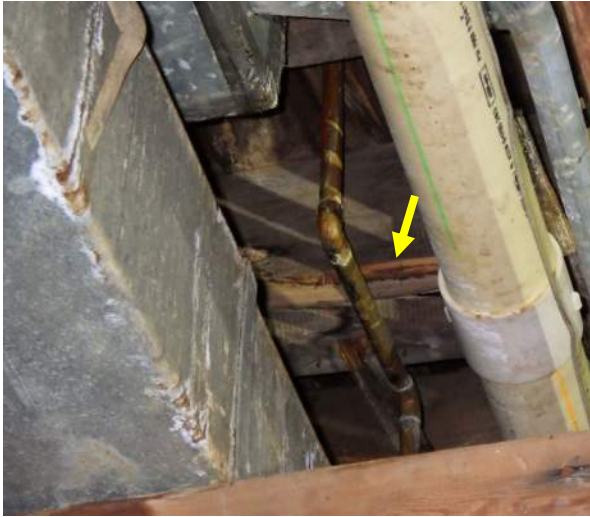
Fracture in second story floor joist

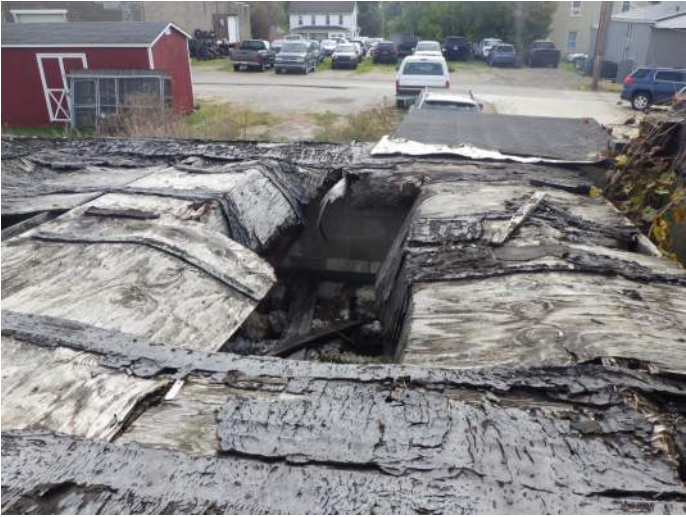
Deteriorated structure at rear

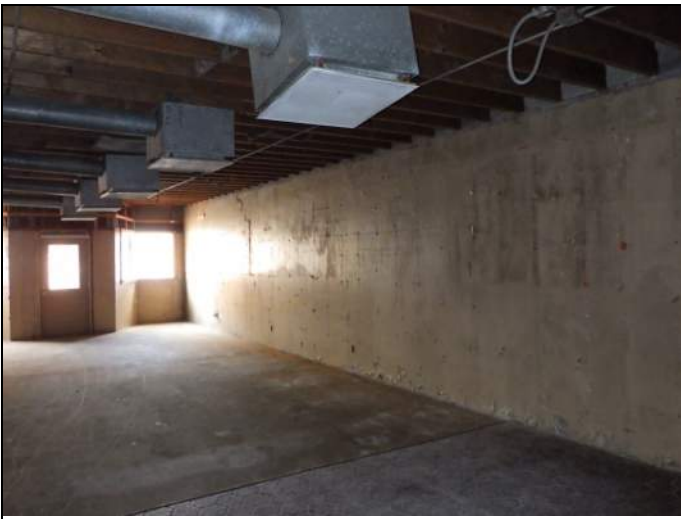
Overview of first story of east building

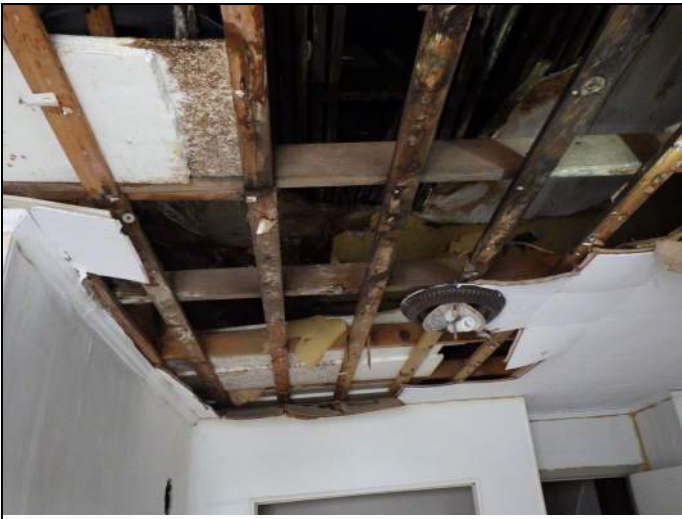
Area of water leak from roof on second story

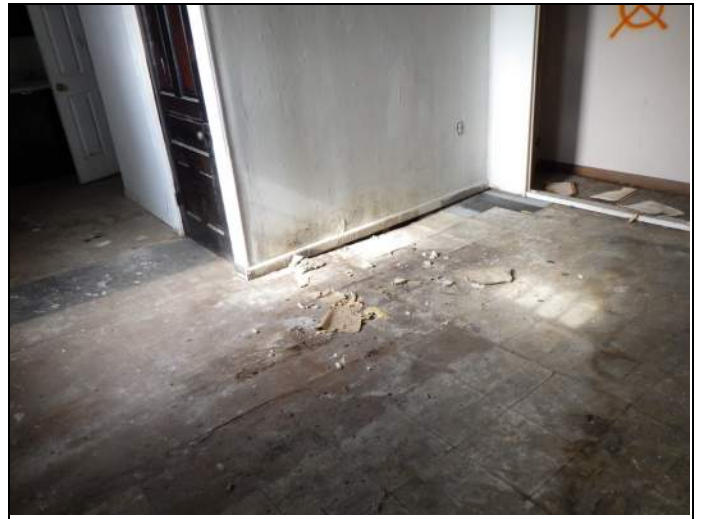
Area below water leak on second story

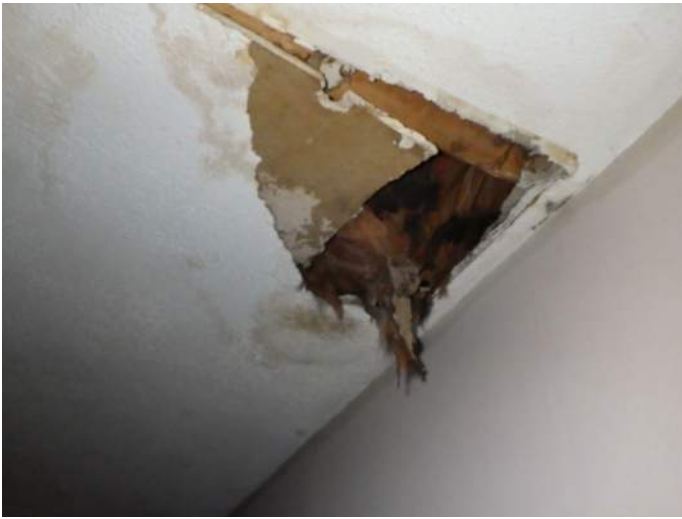
Area of water leak from roof on second story

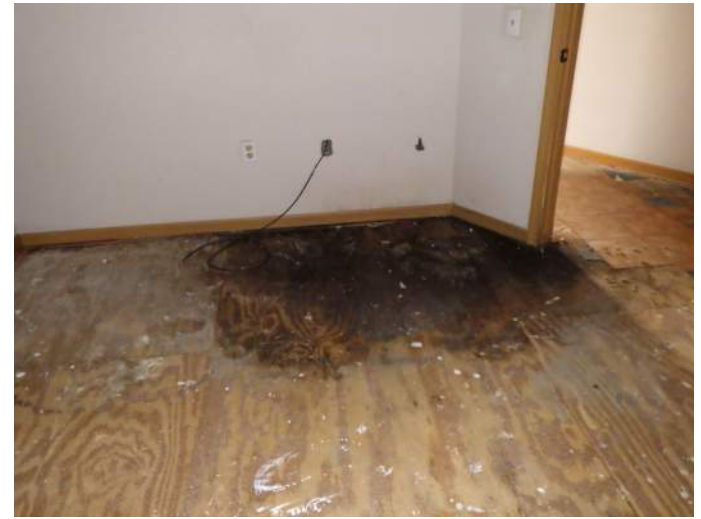
Area below water leak on second story

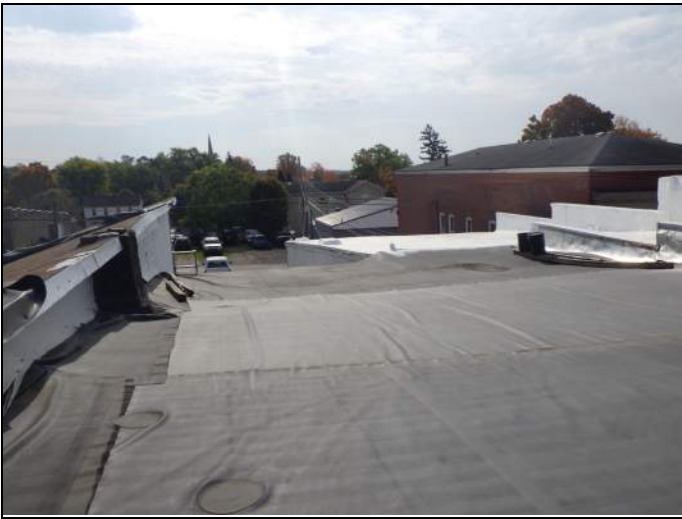
Overview of upper roof looking south

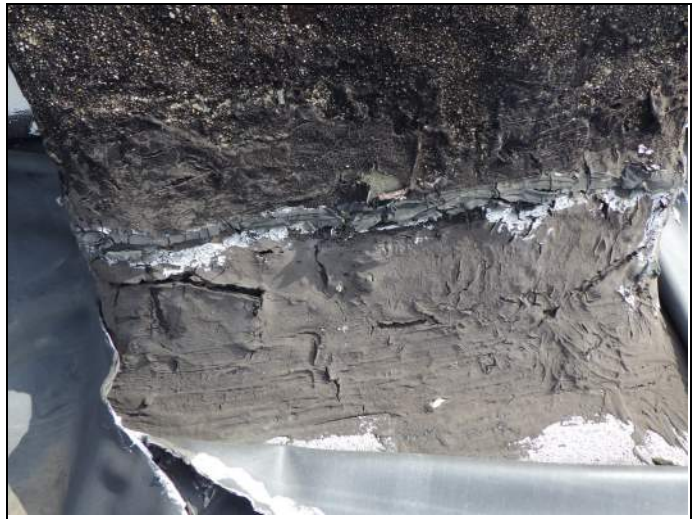
Cracked and deteriorated sealant

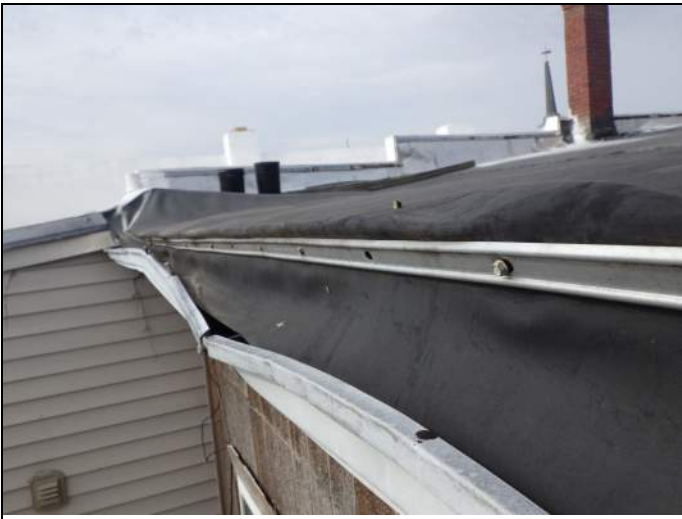
Gutter along south roof edge

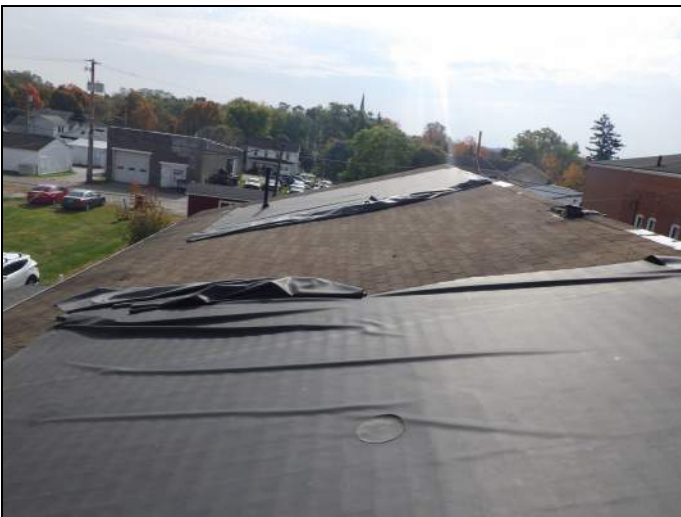
Overview of roof, looking south

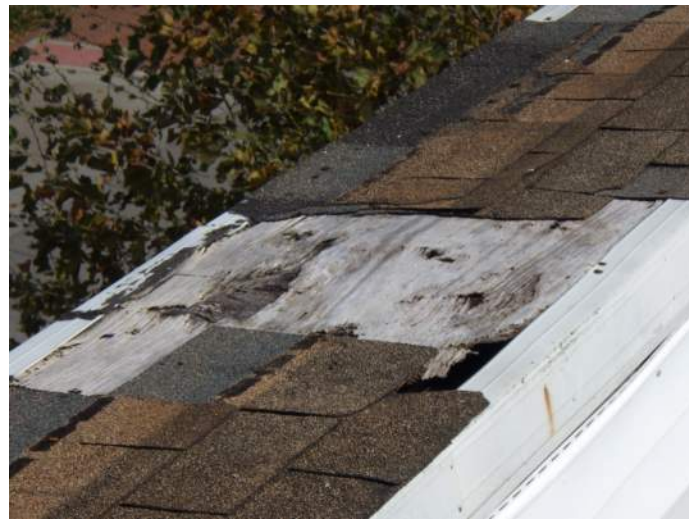
Missing shingles and plywood over parapet

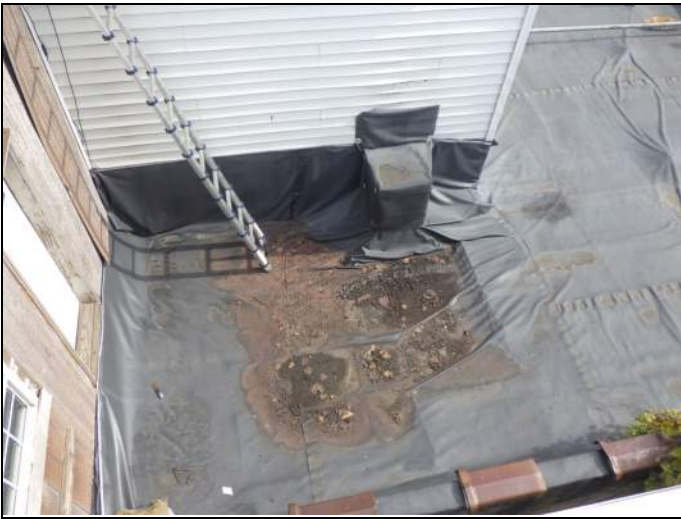
Overview of lower roof

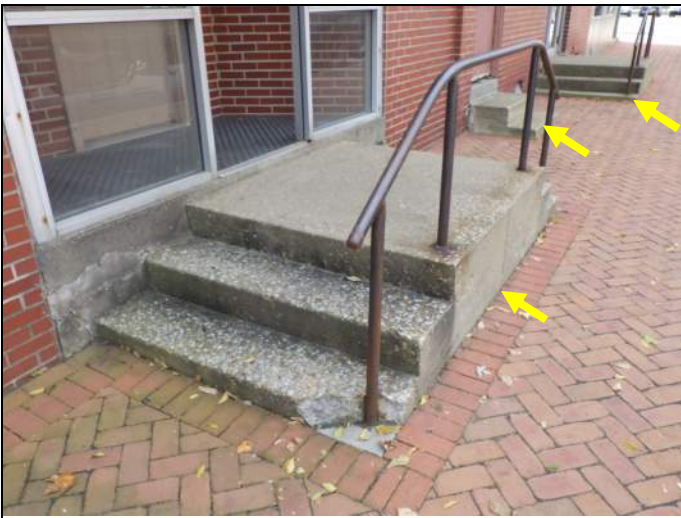
Stairs into first and second stories at front
