**RE:** **RISE Ohio Project Proposal: 21 to 45 West Columbus Street Building Evaluation**

# JSR RENTALS, LLC BUILDING EVALUATION

21 to 45 West Columbus Street, Nelsonville, Ohio  
American Structurepoint Project No. 202200371, Phase 1200  
March 10, 2023

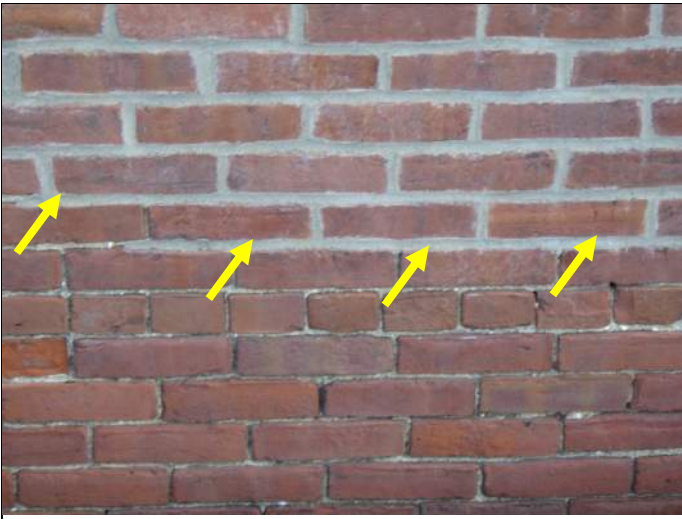
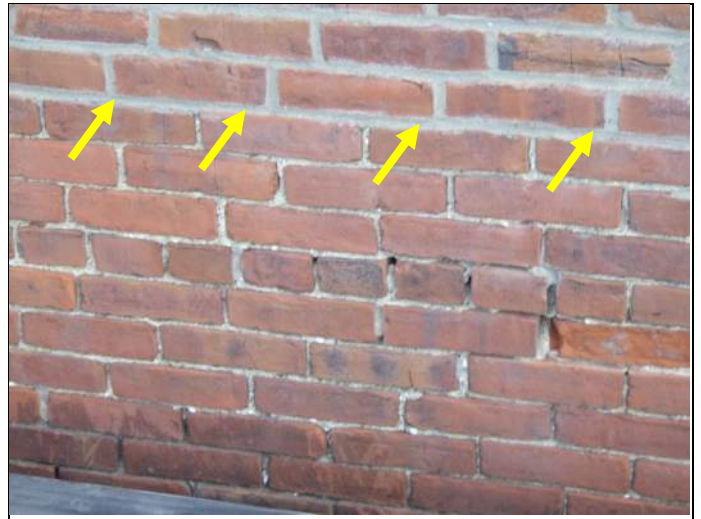
- Several areas of the brick masonry had been repaired by tuck pointing with incompatible cementitious mortars, which has caused some of the bricks to spall. Cementitious mortars prevent moisture from escaping the brick masonry and contribute to premature deterioration of individual bricks.

Typical cementitious mortar

- Repair brick masonry by removing incompatible mortar, tuck-pointing with a compatible mortar, and replacing deteriorated bricks.
- Re-align the bowing section of wall to vertical plumb.
- Apply sealant between window frames and panes to any areas of deteriorated gasket.
- Clean and re-paint the steel headers above the storefronts.

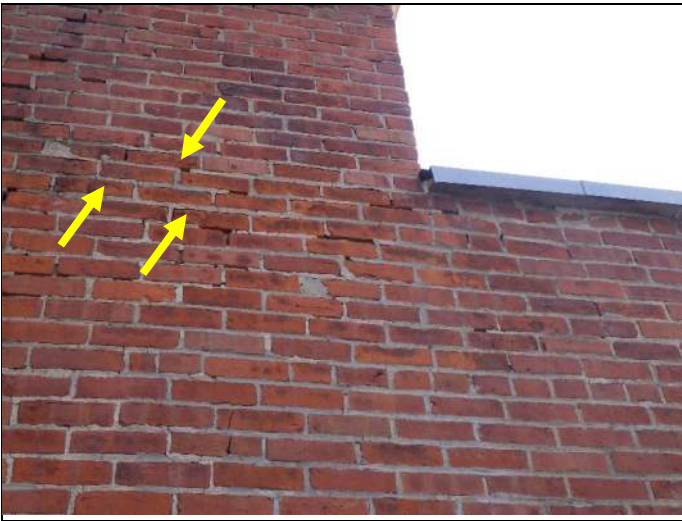
Spalled brick at cementitious mortar

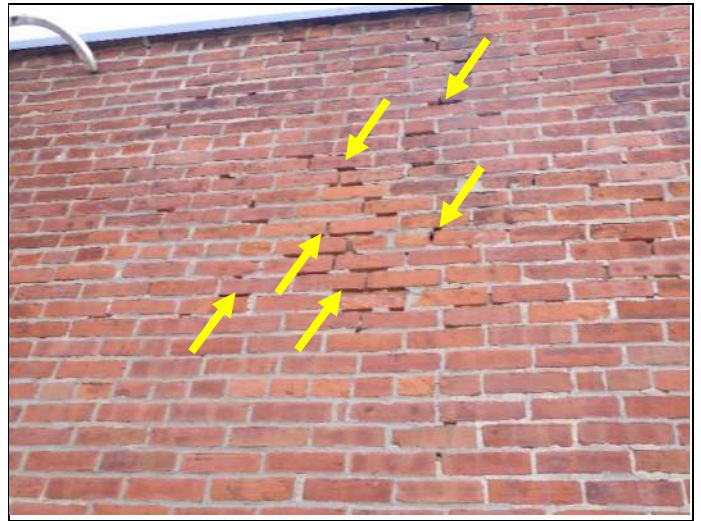
- The mortar had deteriorated in a few areas of the brick masonry.
- Previous repairs to the brick masonry and stone were observed in a few areas of the storefront.

Mortar deterioration

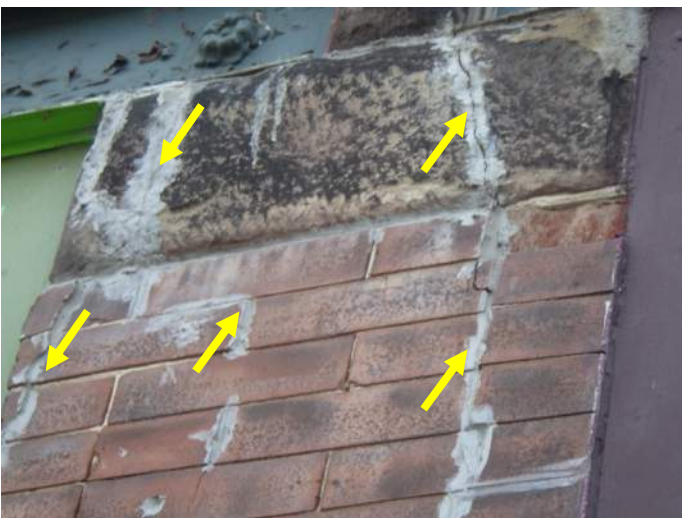
Previous stone and brick repairs

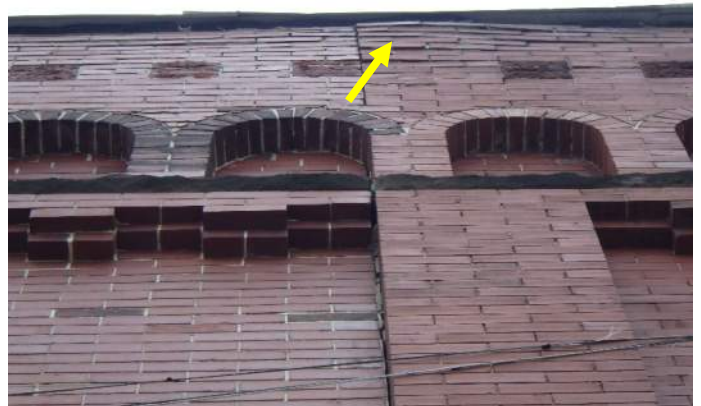
- Above the storefront of the building, an area of the brick wall was observed to be bowing outwards.
- The wood, aluminum, and vinyl framed doors were all in good condition with little to no staining.

Brick wall bowing out above storefront

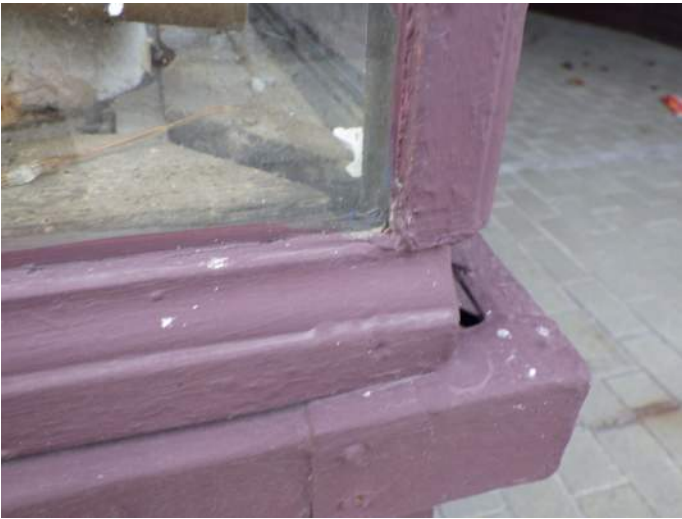
- The wood-framed windows were generally in fair condition, with minimal staining and deterioration. The gasket between the frame and pane was deteriorated in a few windows.

Typical window condition

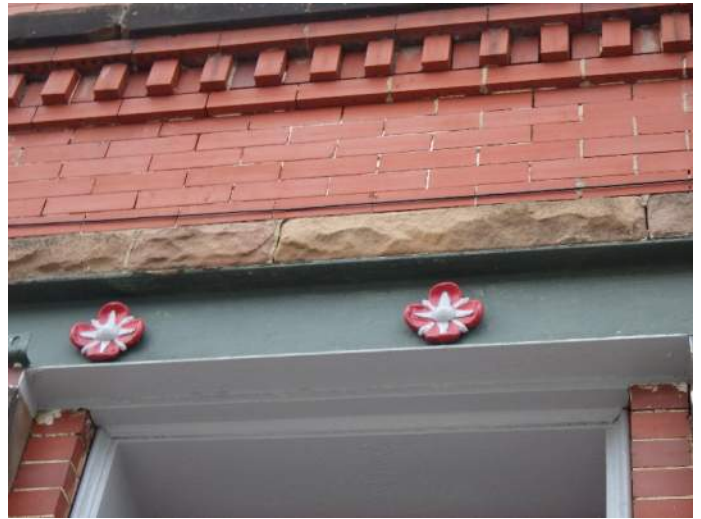
- The paint on the surface of the steel headers above the storefronts was peeling and flaking throughout.
- The stone lintels above the building's windows were in good condition, exhibiting light staining throughout.

Typical stone and steel header above storefront

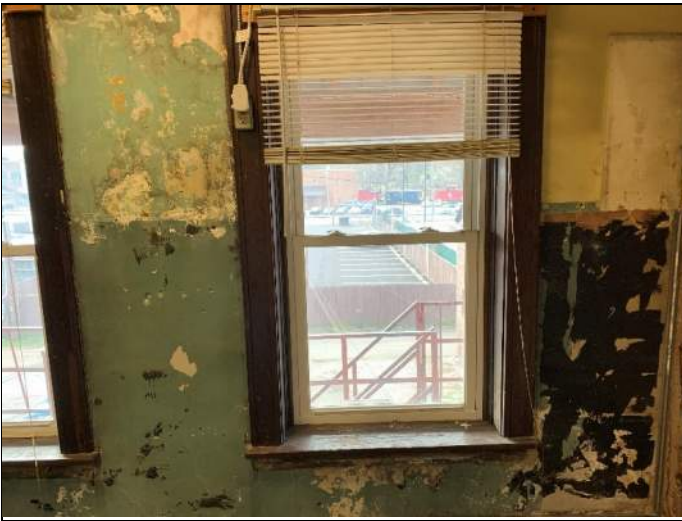
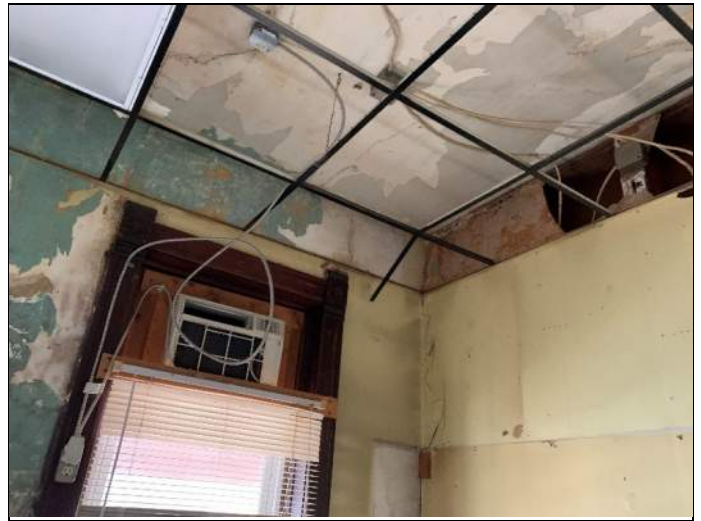
- Plaster wall finishes in some of the second-story residential apartments has deteriorated and paint was flaking from the walls.
- The ACTs of the suspended ceilings in some of the second-story residential apartments are stained or missing.

Wall condition at some residential apartments

- Resurface deteriorated plaster walls and repaint residential apartments.
- Replace stained and damaged acoustical tile ceilings in residential apartments.

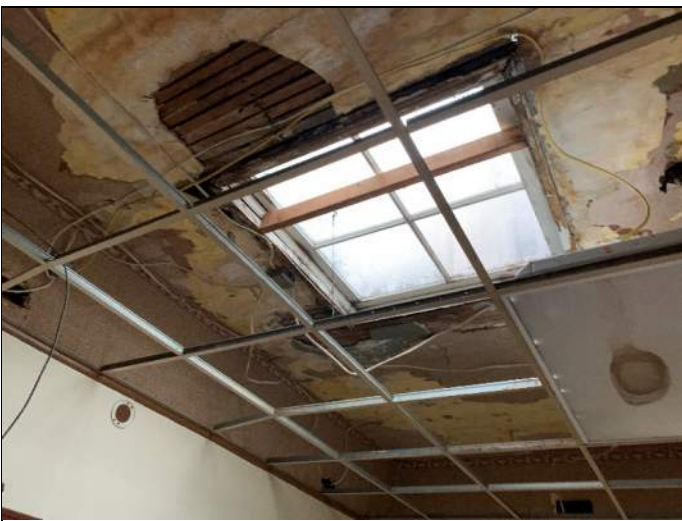
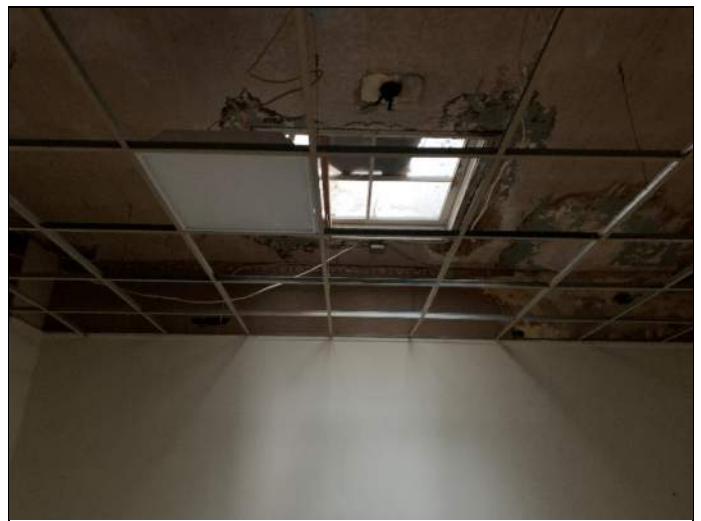
Ceiling condition at some residential apartments

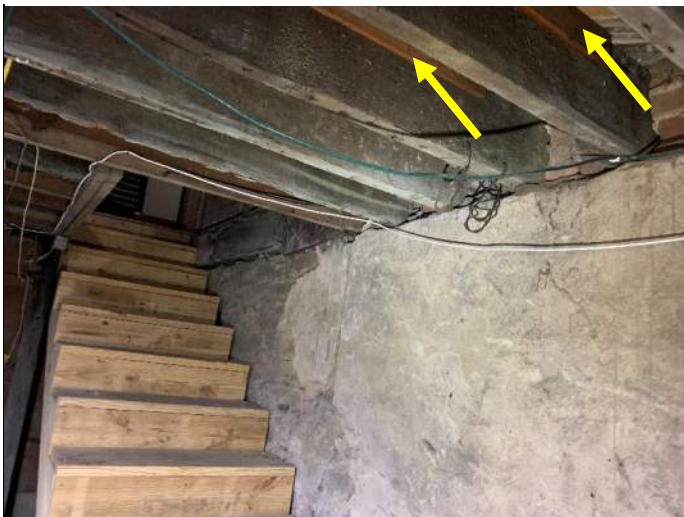
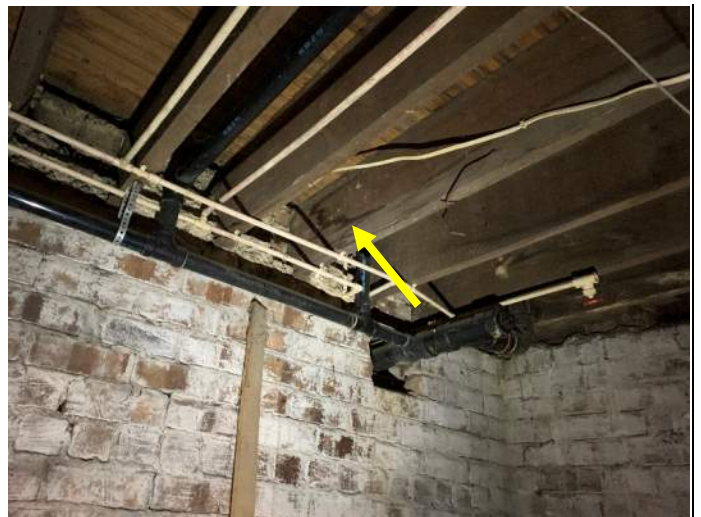
- Some deteriorated floor joists visible in the basement had been previously repaired by "sistering" with new joists. These supplemental joists appear to be inadequate for reinforcement and should be replaced with properly sized joists.
- Minor water stains were observed on the floor joists visible in the basement.
- Minor mortar deterioration was observed in the stone and brick masonry walls.

Floor joists "sistered" with new joists

- Tuck-point brick and stone masonry walls as needed. (Note that costs for brick masonry tuck-pointing are included in the Architectural System subtotal in our opinion of probable costs).
- Repair or replace deteriorated floor joists with appropriately sized sistered joists.

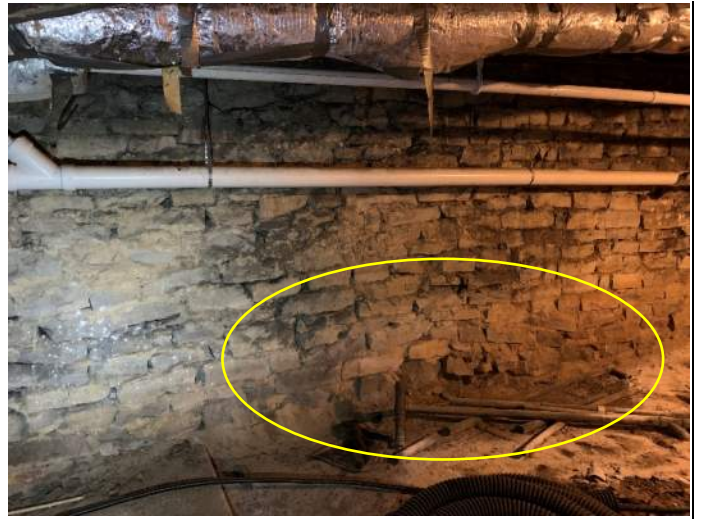
Deterioration of stone masonry wall

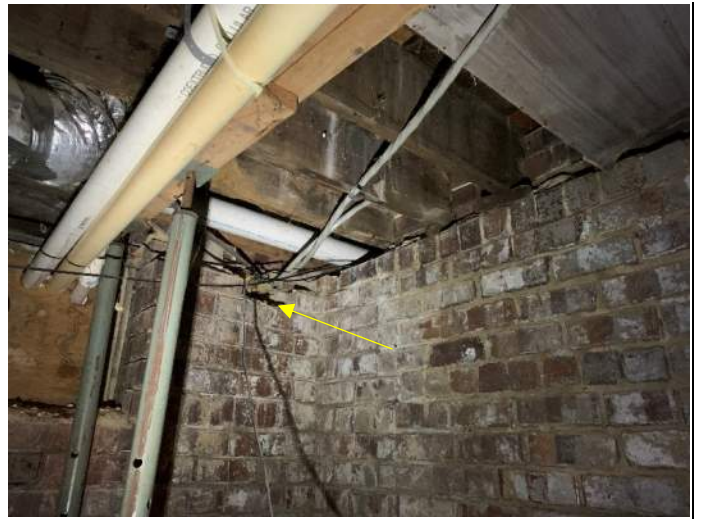
Deterioration of brick masonry wall

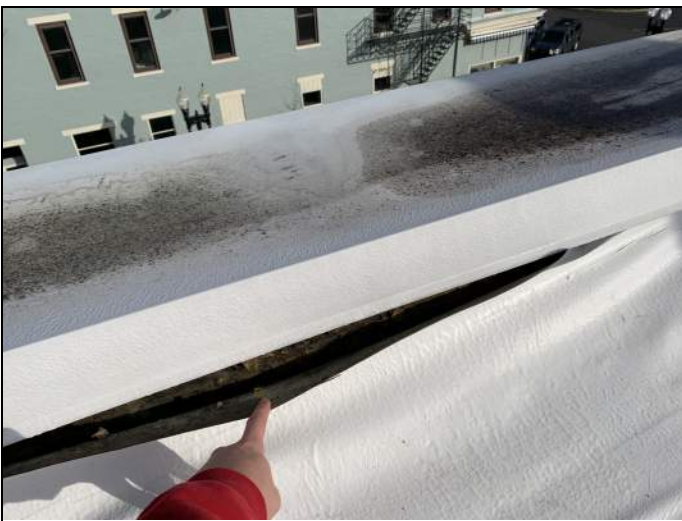
- The edges of the EPDM membrane were loose or improperly overlapped at several locations.
- The parapet ends were often open, allowing storm water to enter the building envelope.
- No termination bars were used to fasten the roofing membrane to the underlying brick masonry at some locations, and the membrane had been adhered to the masonry.
- Some chimney crowns had deteriorated.
- The tops of several apparently obsolete chimneys were open.
- Some vent hoods were missing their caps and had been covered in EPDM roofing membrane.
- The skylights were in poor overall condition. Sealant along joints in skylights had deteriorated, several panes of glass had cracked, and the steel frames are corroded in some area.

Loose and improperly overlapped roofing

- Provide proper termination along the edges of the membrane roofing, including new flashing and termination bars.
- Cover open chimneys and replace deteriorated chimney crowns to prevent water infiltration.
- Install new vent hoods where they are missing.
- Replacing sealant may reduce water intrusion as a short term and ongoing repair; however, replacing deteriorated skylights is recommended to prevent long-term water intrusion.

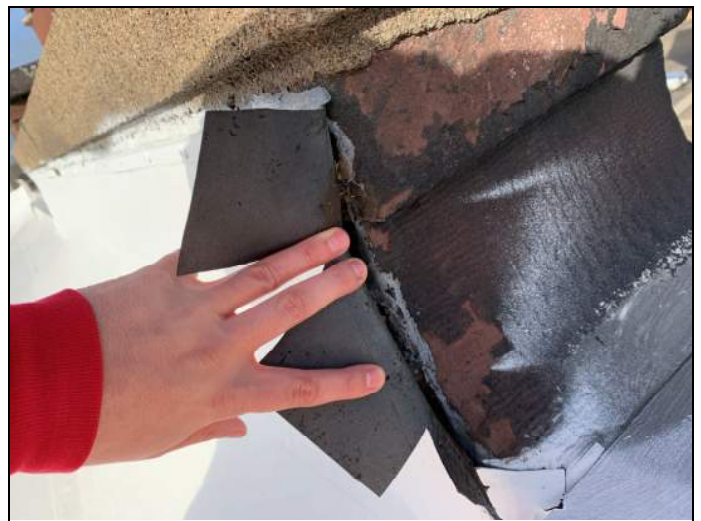
Loose roofing at parapet end

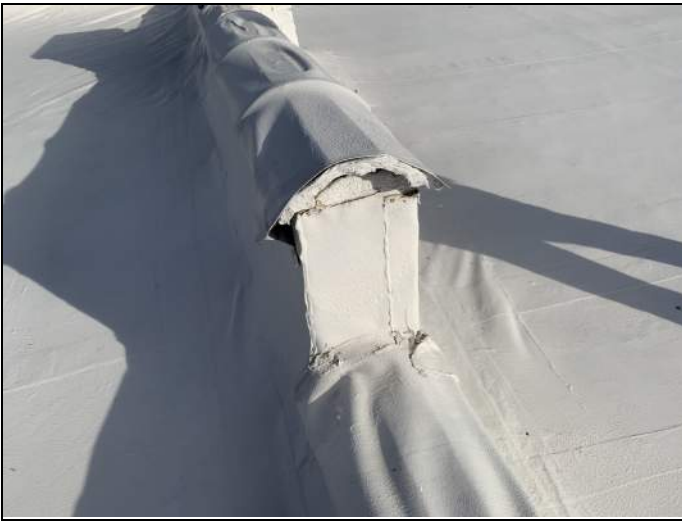
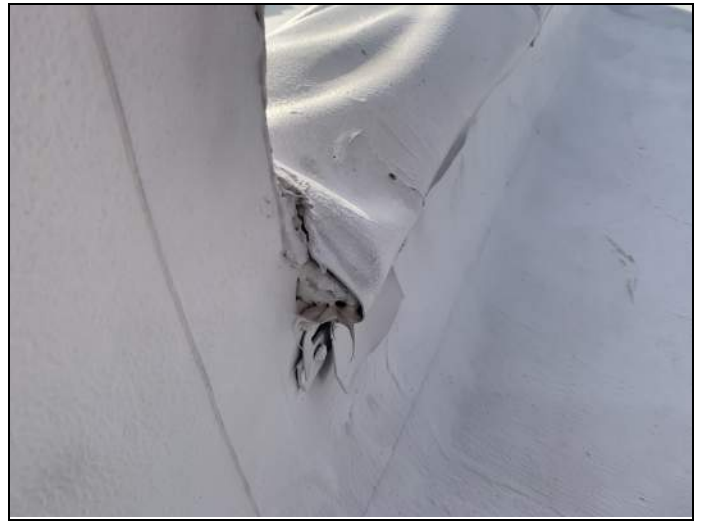
Open parapet end

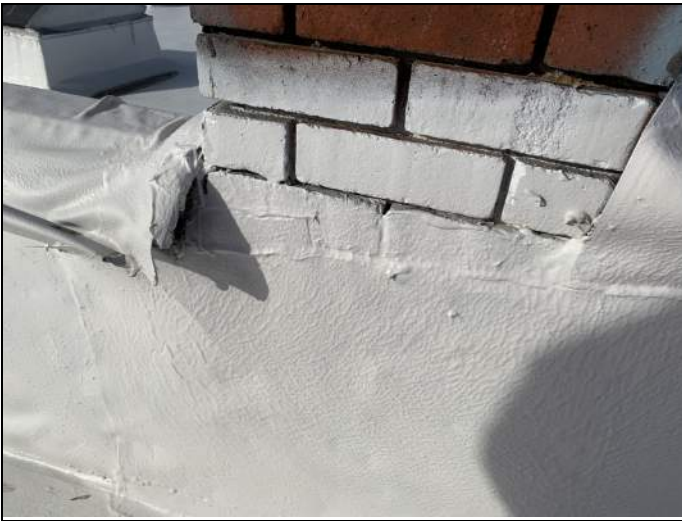
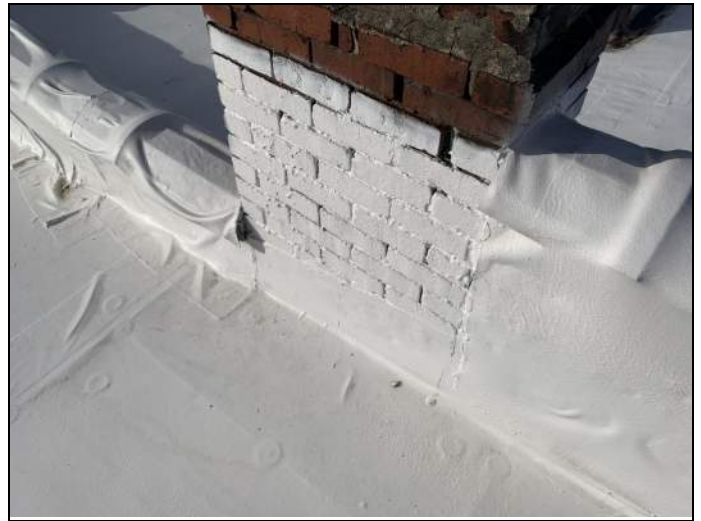
Membrane adhered to masonry

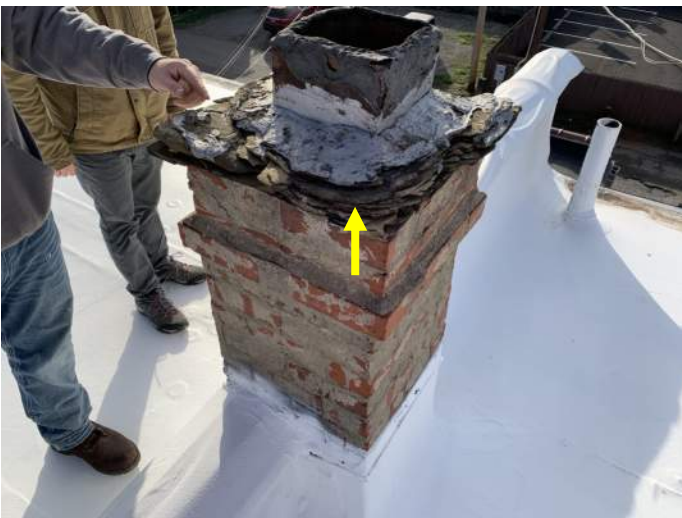
Deteriorated chimney crown

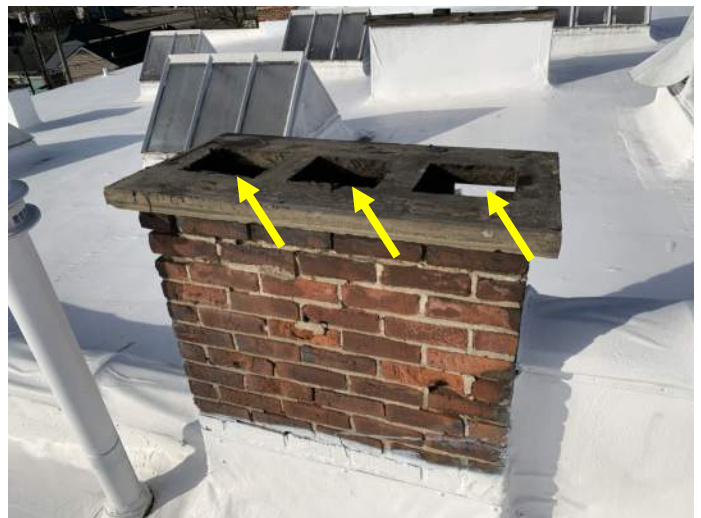
Absence of chimney flue caps

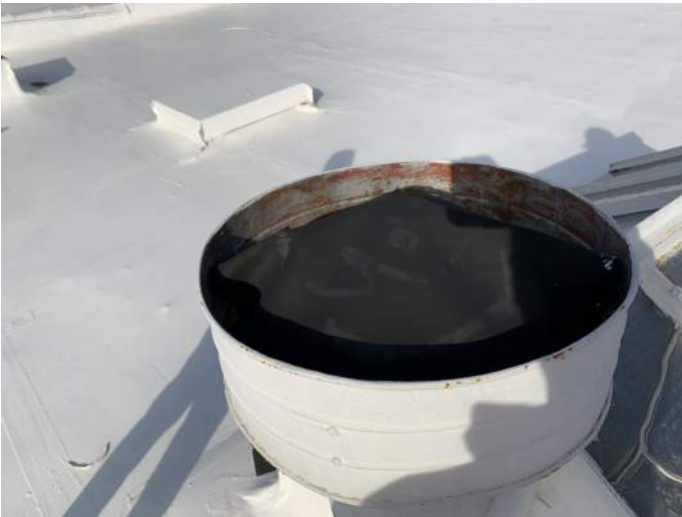
Vent missing hood covered with EPDM membrane

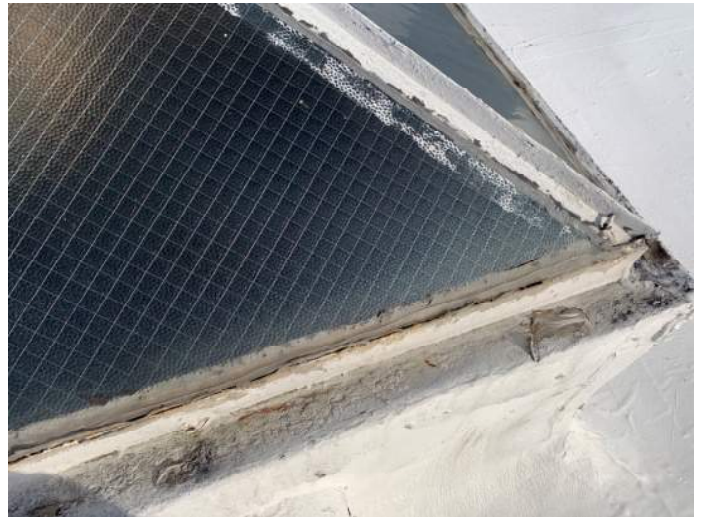
Deteriorated sealant along skylight joint

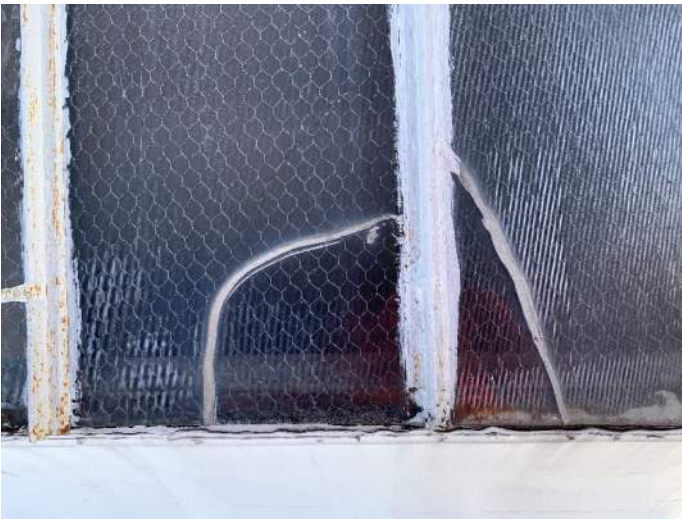
Cracked skylight glass

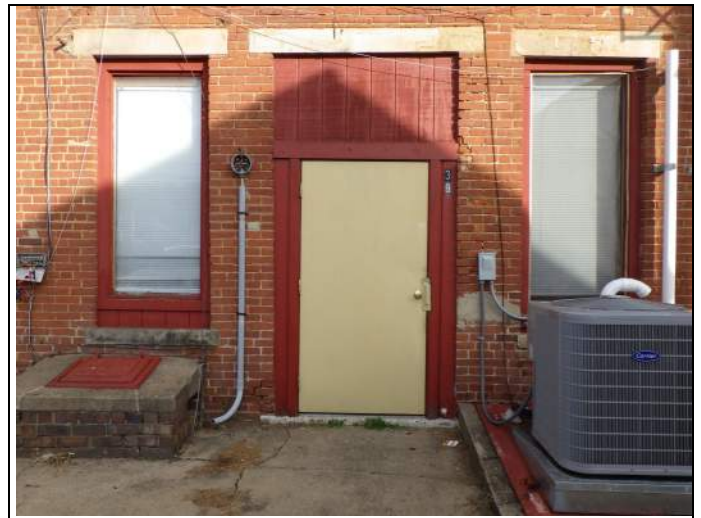
Access to the first story is provided by ground-level entrances along the front of the building that generally comply with ADA Accessibility requirements. First story entrances along the back of the building exceeded the maximum change in level and are not considered ADA accessible. The second story is only accessible by a staircase and is not ADA accessible.

Typical first story rear entrance

- Provide ADA accessible ramps at the rear first story entrances.

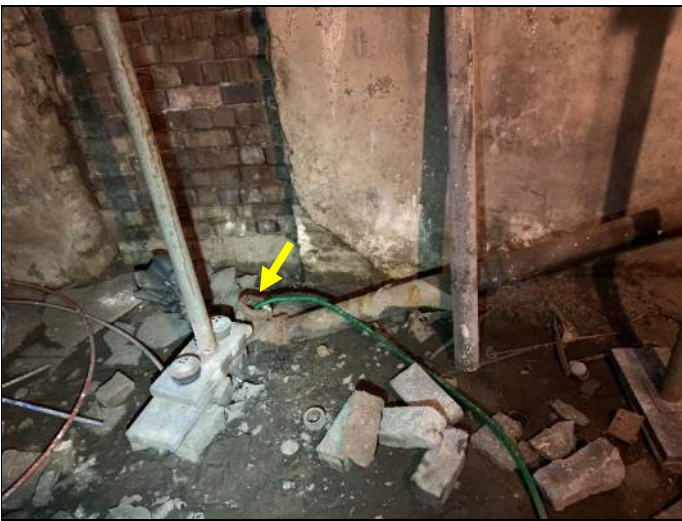
The majority of the plumbing systems are not included in the scope of this project and were not evaluated. The specific issue of waste water backing up into the basement was discussed and is included in this report. A fitting was open where the waste water pipe emerges from the floor that a hose from a dehumidifier discharges into. Also, no backflow preventer valve was present to prevent sewage backup into the basement.

Waste water pipe with open fitting

1. Provide proper drain for dehumidifier to discharge.
2. Install backflow preventer valve.

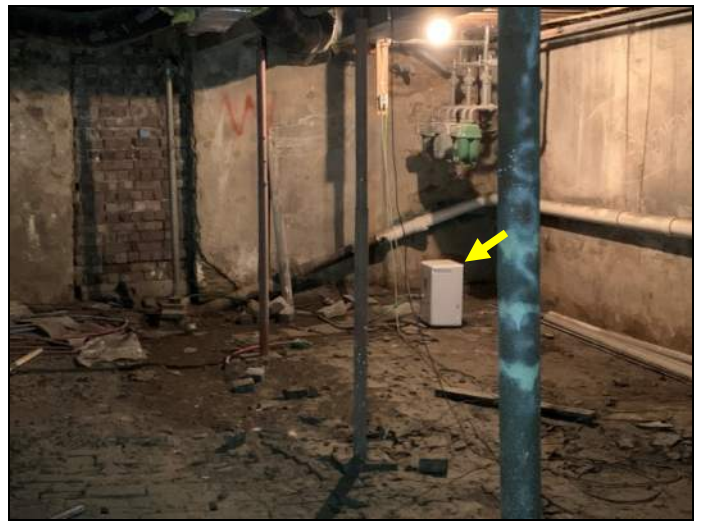
Dehumidifier
