RE: RISE Ohio Project Proposal: Putnam Commons Building Evaluation and Prospectus

PUTNAM COMMONS BUILDING EVALUATION AND PROSPECTUS

American Structurepoint Project No. 202200371

December 9, 2022

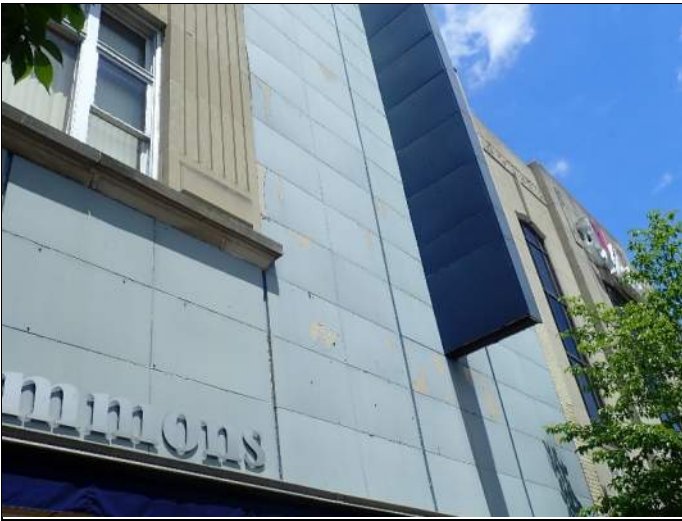
- Paint was flaking from the metal panels.
- The wood-framed windows were generally in poor condition. Many windows were missing glass panes, or the wood frames had deteriorated.
- Four window openings on the first story had been covered in plywood.
- Few isolated areas of the brick masonry had deteriorated mortar and bricks.

Paint flaking from metal panels

- Resurface painted metal panels.
- Repair and refinish wood-framed windows and install wood-framed storm windows.
- Replace missing window glass.
- Install new wood-framed windows at the missing first-story window openings.
- Repair deteriorated bricks and tuck point

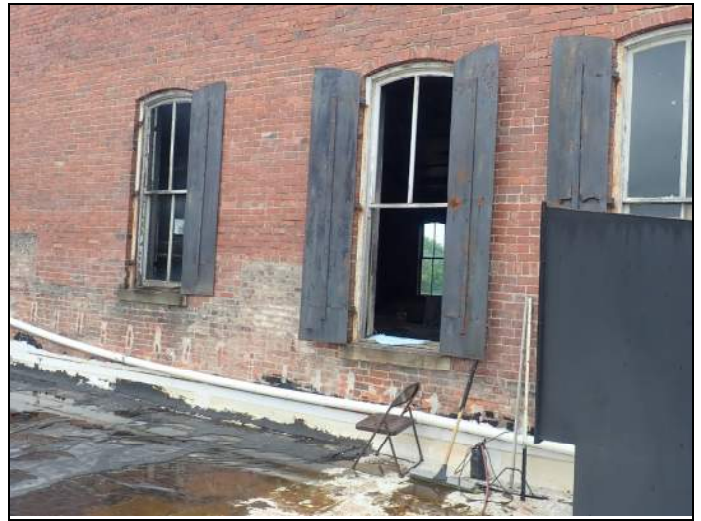
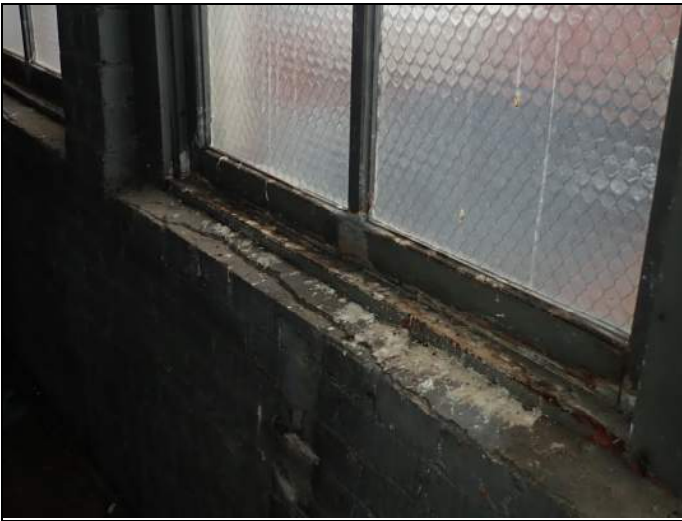
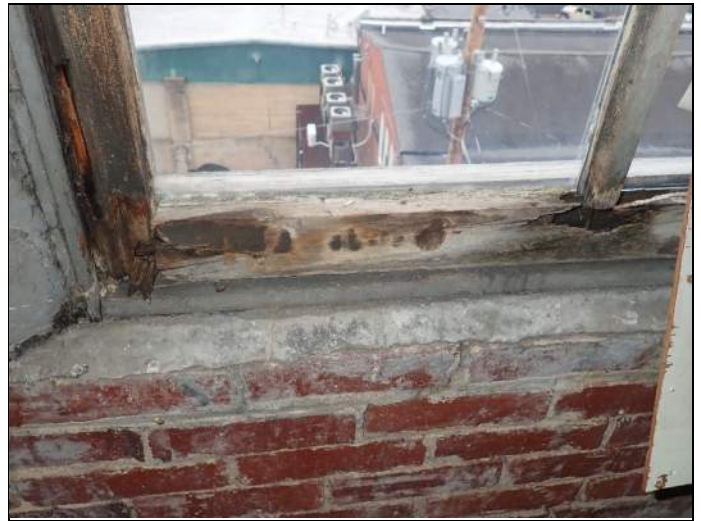
Typical window condition

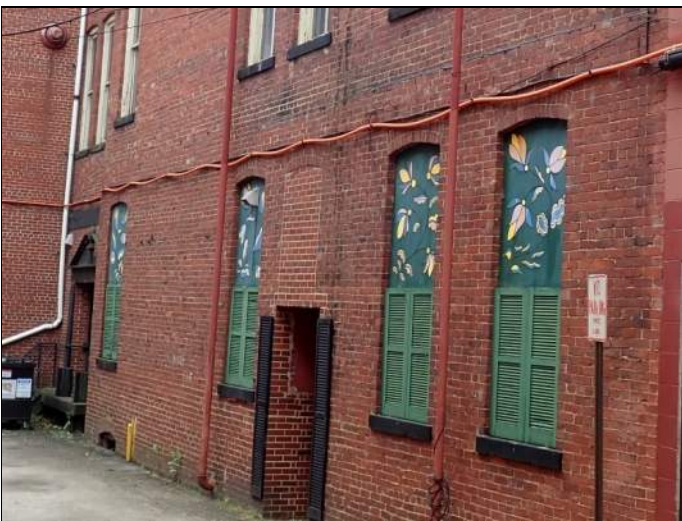
Missing windows

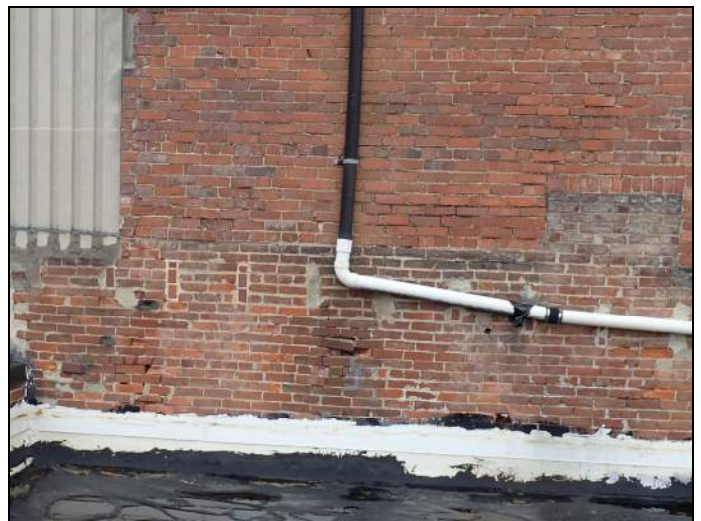
Damaged brick masonry

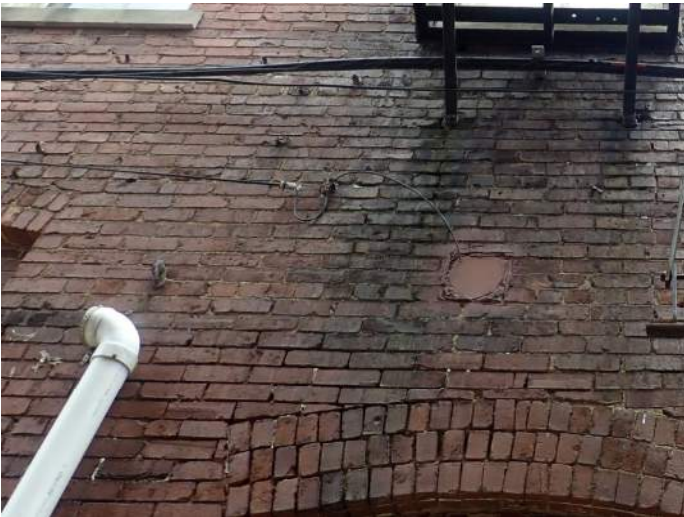
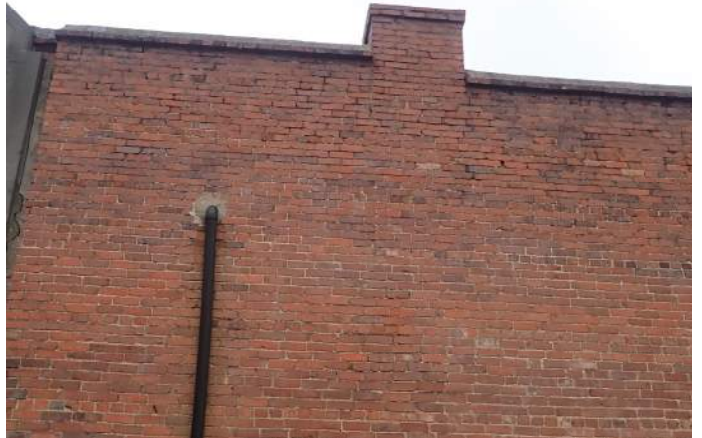
Deteriorated mortar between bricks

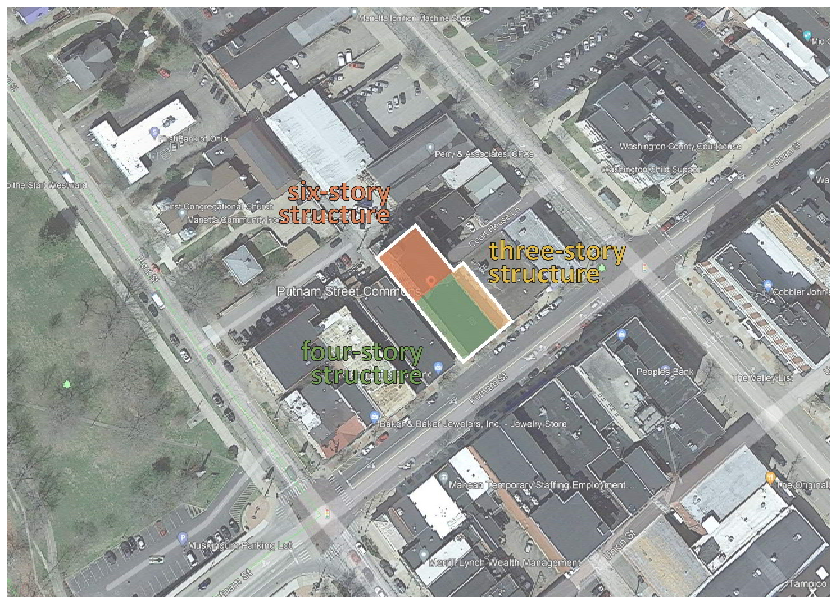
The building is comprised of three distinct structural systems that are discussed separately in the following sections, as seen in the image below.

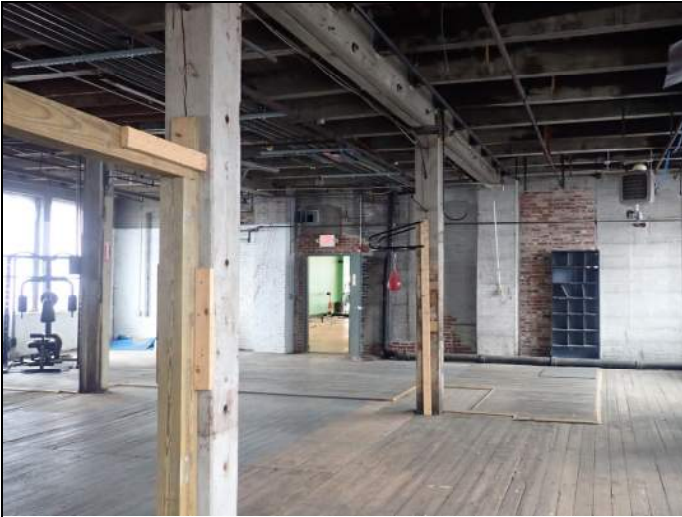
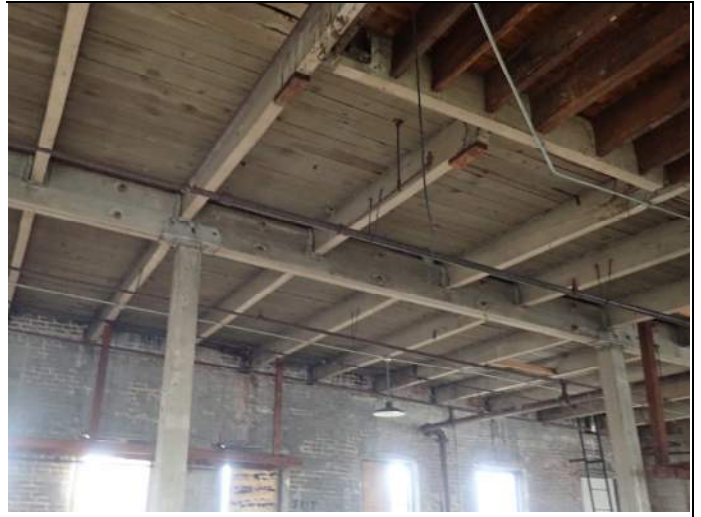
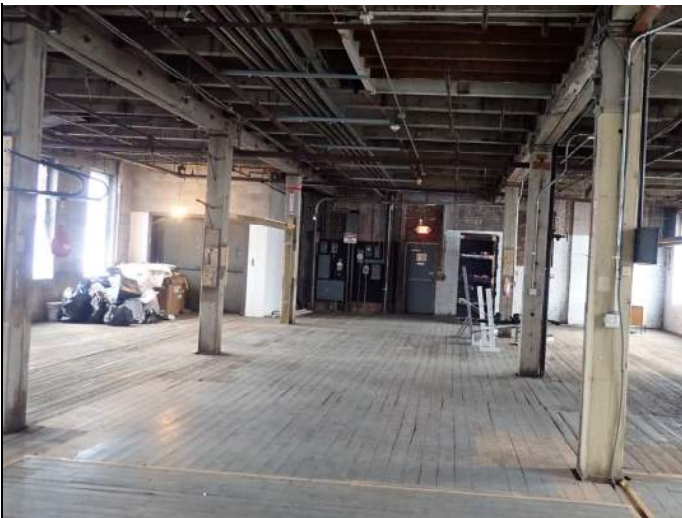
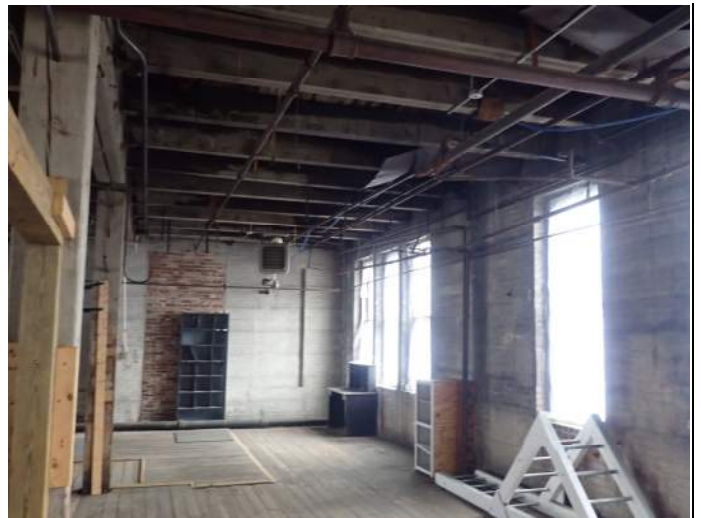
The six-story portion of the building is believed to be the original structure and is situated behind the four-story structure that fronts Putnam Street. Interior framing consists of two rows of timber post and beam frames. The frames support wood joists and wood plank floor and roof decking. The exterior load-bearing walls consist of multi-wythe brick masonry. A basement below the structure consisted of multi-wythe brick masonry walls and a cast-in-place concrete floor slab.

Typical framing of six-story building

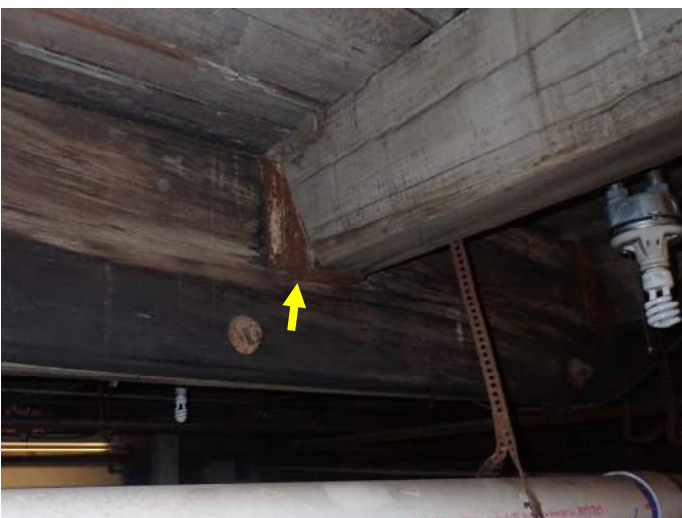
- Metal beam hangers had corroded in the basement.
- Wood beams had crushed at their supports. See additional assessment recommendations section.
- Staining characteristic of water infiltration through the roof was present on the wood framing throughout the building.
- Minor deterioration of the wood plank decking was present at the water stains.

Corroded metal beam hanger

- Immediately cordon off from access and shore any areas exhibiting rotting or crushed wood
- Hire a structural engineer to analyze the crushed wood and repair or replace as necessary. Costs are included in the analysis; however, more accurate repair estimates can only be

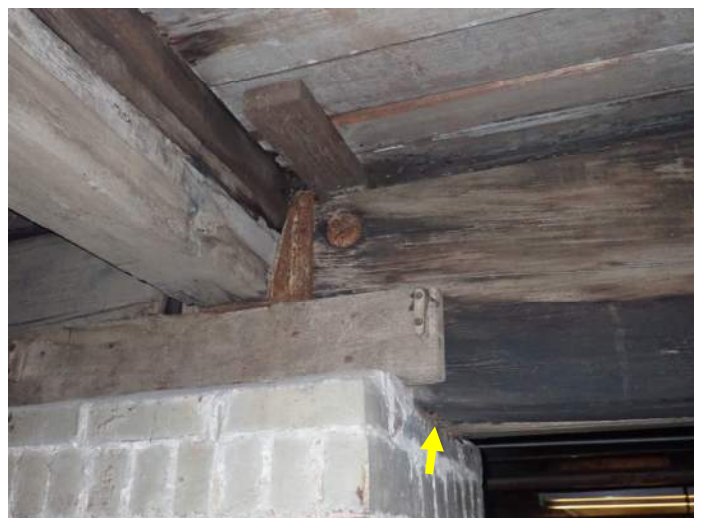
Crushed wood at support

Perform a structural assessment of crushed beam bearing in the basement to determine appropriate repairs if necessary. Until a detailed structural assessment can be performed and any necessary repairs completed, temporary shoring should be installed by a qualified shoring contractor at any crushed beam locations.

determined after an engineer has completed a more detailed analysis beyond this project's scope.

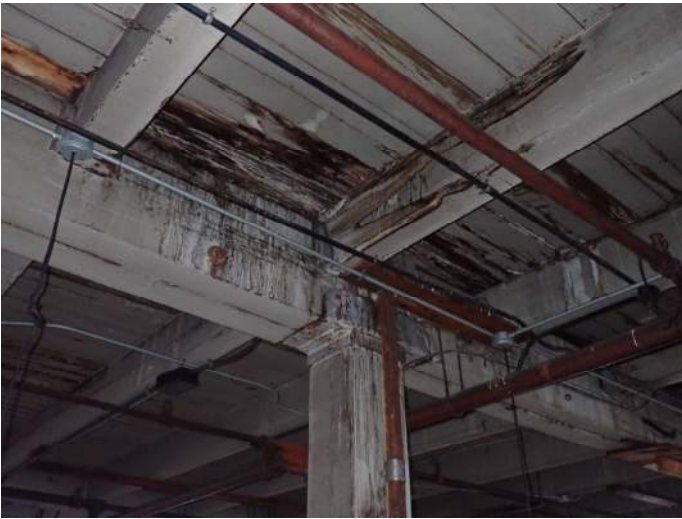
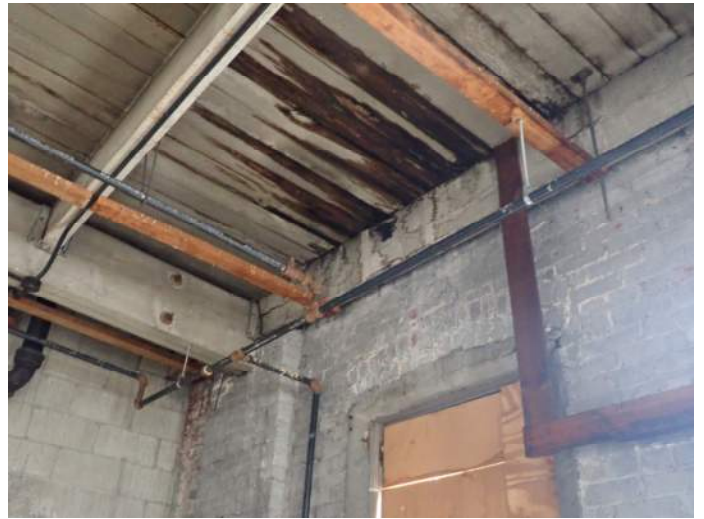
Typical water stains

- Replace the roof to eliminate leaks.
- Remove and replace deteriorated wood plank decking during roof repairs.

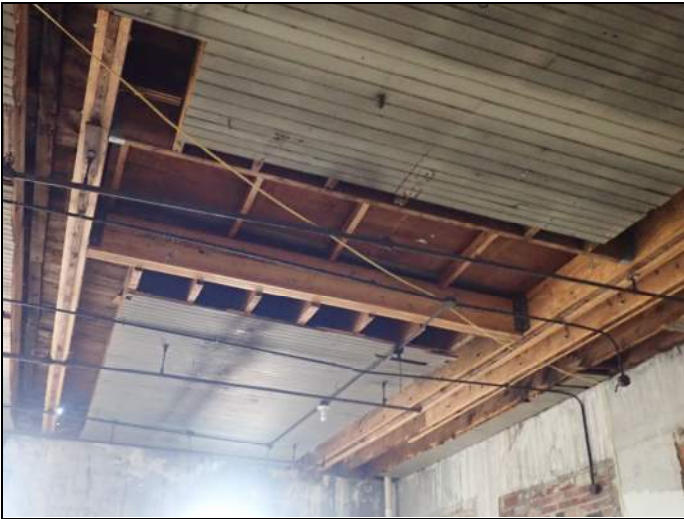
- Prior repairs had been made to the wood roof framing, which consisted of new beams and joists.
- Staining characteristic of water infiltration through the roof was present on the ceiling panels along the west edge of the roof.
- Minor deterioration of the ceiling panels was present at the water stains. The wood plank roof decking was not exposed; however, some deterioration of the decking is presumed.

Prior structural repairs on roof

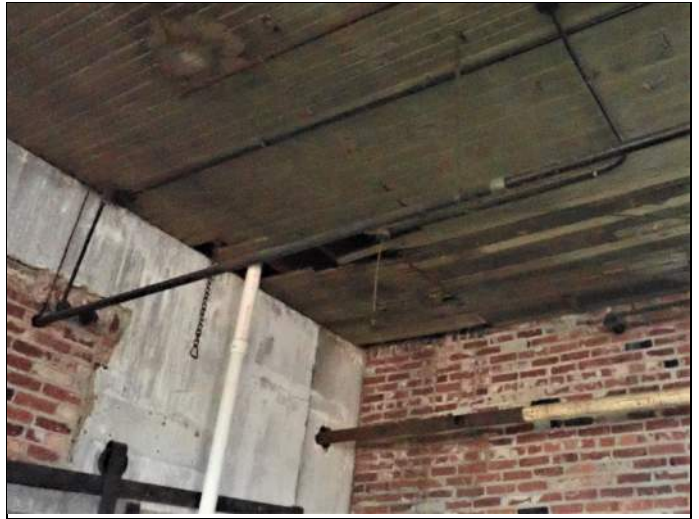
Water-stained ceiling panels

- Replace the roof to eliminate leaks.
- Remove and replace deteriorated any wood plank decking during roof repairs.

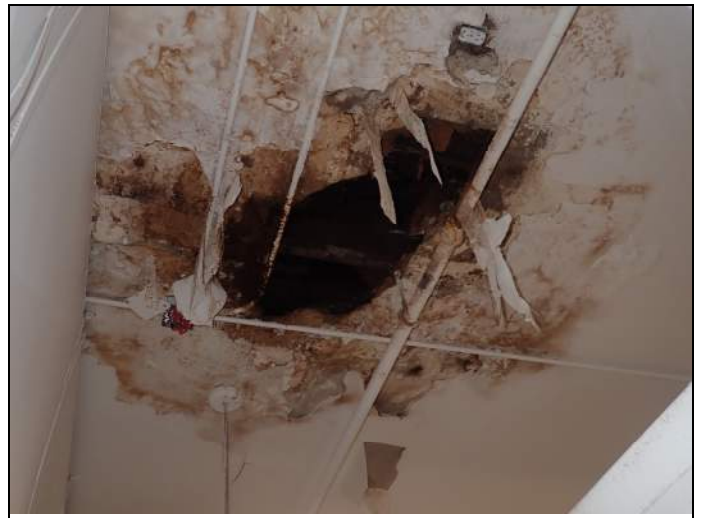
- Water stains and deteriorated wall finishes were observed at several locations on the third and second stories, where roof leaks dripped from above.

Stained ceiling and deteriorated roof framing

- Replace the roof to eliminate leaks.
- Remove and replace deteriorated any wood plank decking during roof repairs.

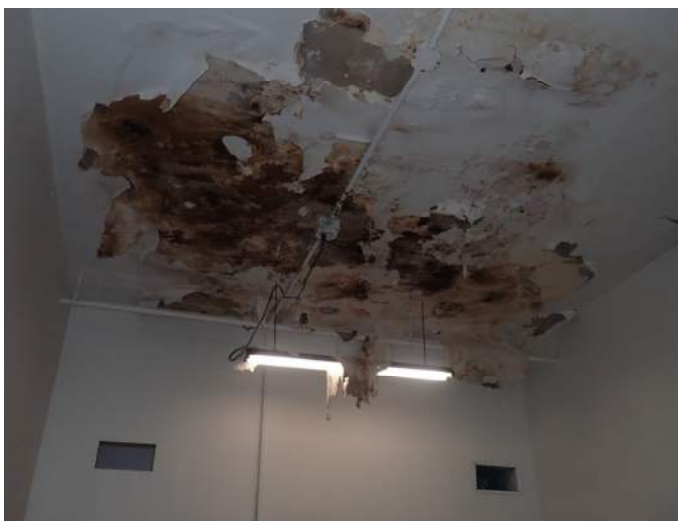
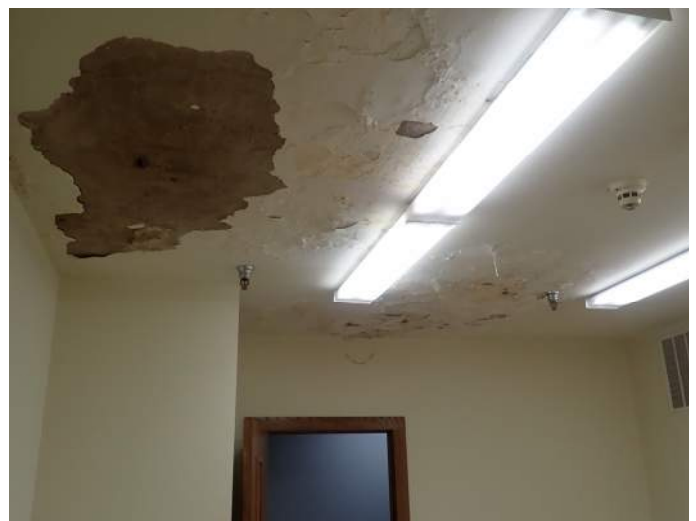
Stained third-story ceiling

Stained second-story ceiling

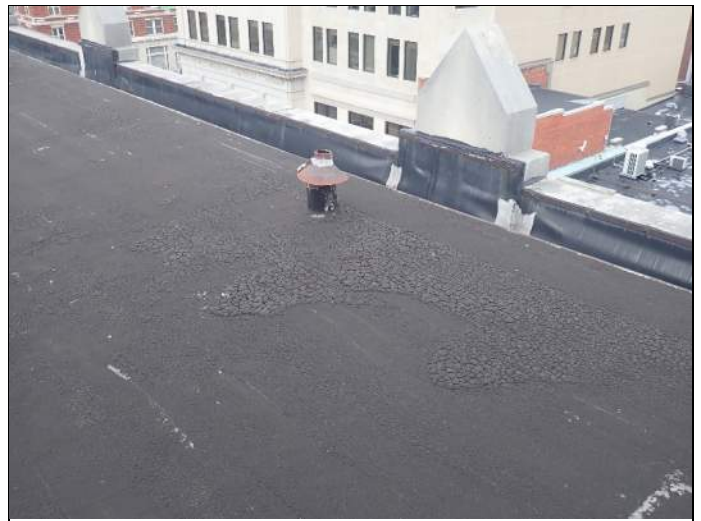
The upper and middle roofs consisted of a modified bitumen (Mod-Bit) roofing system. The upper roof was inaccessible during the assessment because of a locked roof hatch but is believed to be the same type of roofing system, age, and condition as the middle roof. The middle roof sloped from the high side along the east roof edge to the low side along the east wall of the upper stories. Stormwater from the middle roof flows to a scupper located along the base of the east wall. The roof was in fair-to-poor condition, with "alligator" cracking at the asphalt coatings throughout.

Typical condition of the middle roof

- Remove and replace the mod-bit roofs of the upper and middle roofs.
- Remove the spray-foam insulation along the parapet walls and install new protected insulation if necessary.
- Install new light-gauge metal coping over the cracked parge coating of the parapets for the middle roof and assumed for the upper roof.
- Remove obstruction from the east gutter, and install drain with debris screen and/or overflow drain.
- Cover open chimneys to prevent water infiltration.

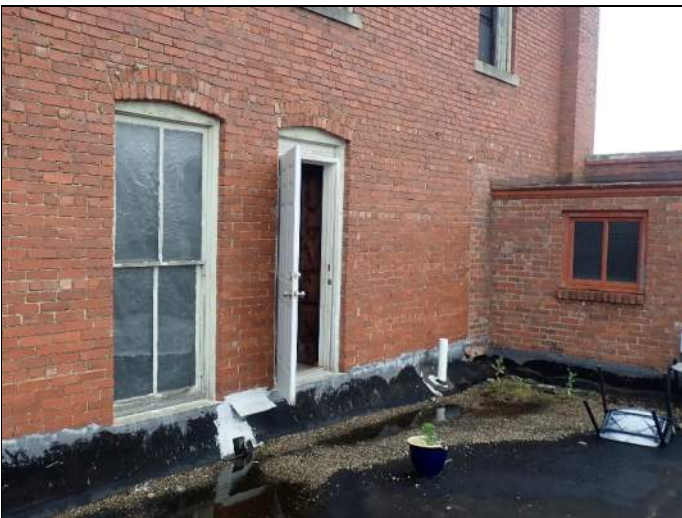
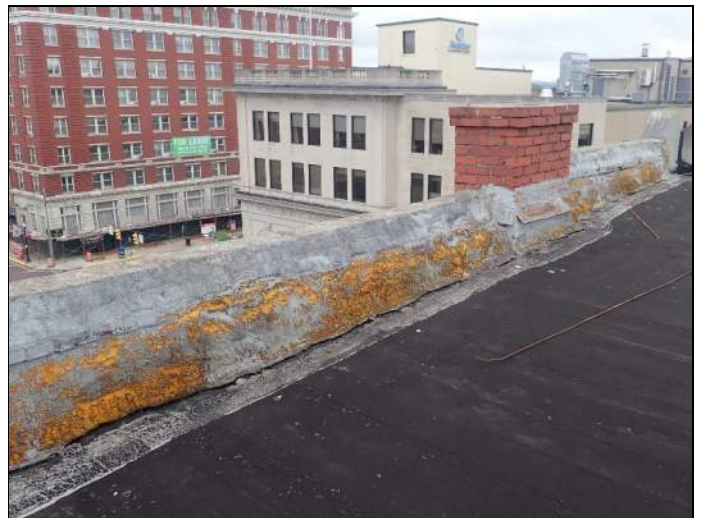
- Dirt and debris had collected along the low edge of the roof, against the upper stories, and in an area above water leaks in the room below.
- Spray foam insulation had been applied along the "inside" face of the parapets, which were unprotected and deteriorating.

Dirt and debris on roof above leak

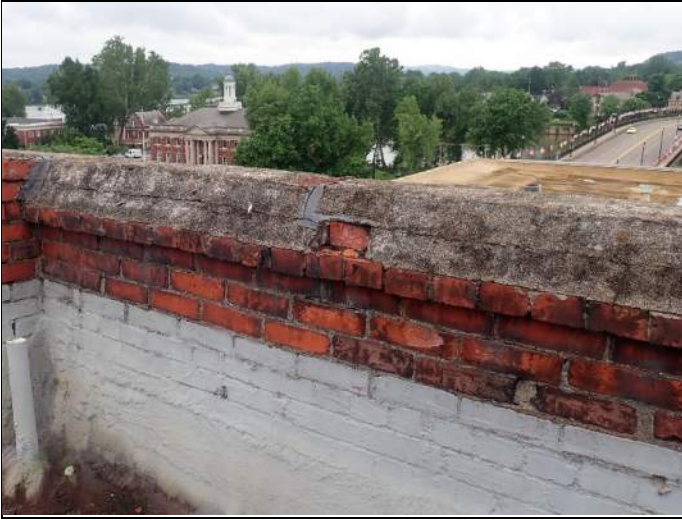
- The top of the brick parapets along the roof edges was coated in a cementitious parge coating. The coating was cracked and deteriorated; remedial sealant was present in some locations.

Deteriorated cement parge coating along top of parapet

Exposed spray-foam insulation along parapet

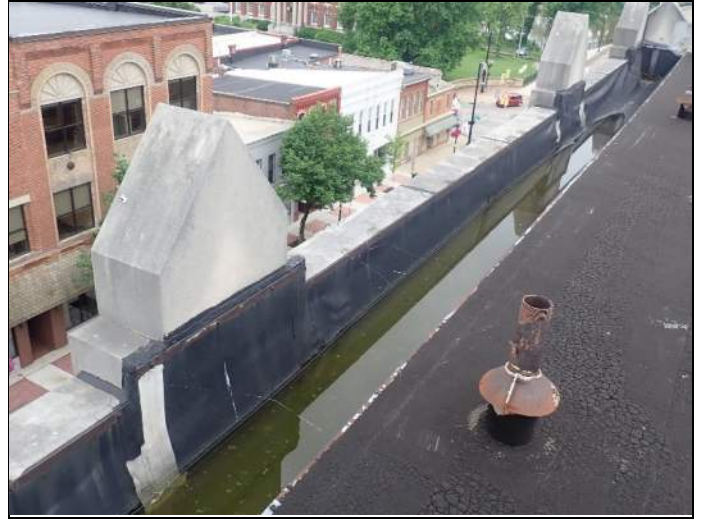
- An ethylene propylene diene monomer (EPDM) lined gutter was located along the east roof edge. The drain was clogged, and the gutter had filled with water. The stone coping along the edge of the gutter had spalled where the fasteners for the membrane attached.

Clogged EPDM-lined gutter

- Reconfigure the roof drain to provide an appropriately sized drain with debris screens and emergency (secondary) overflow drain.

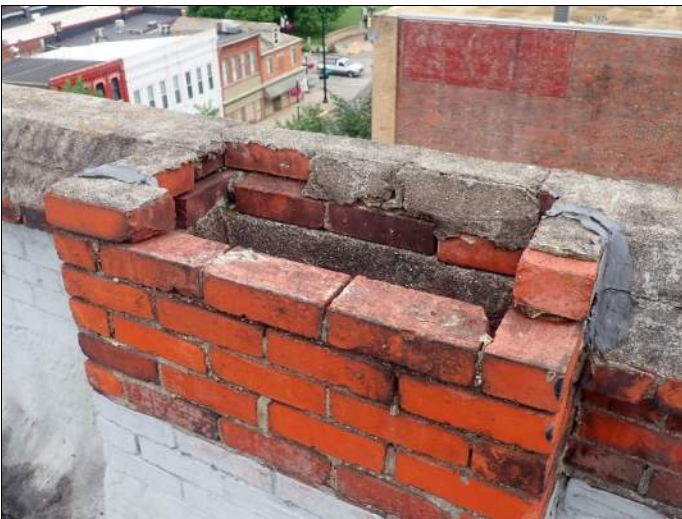
Typical open chimney

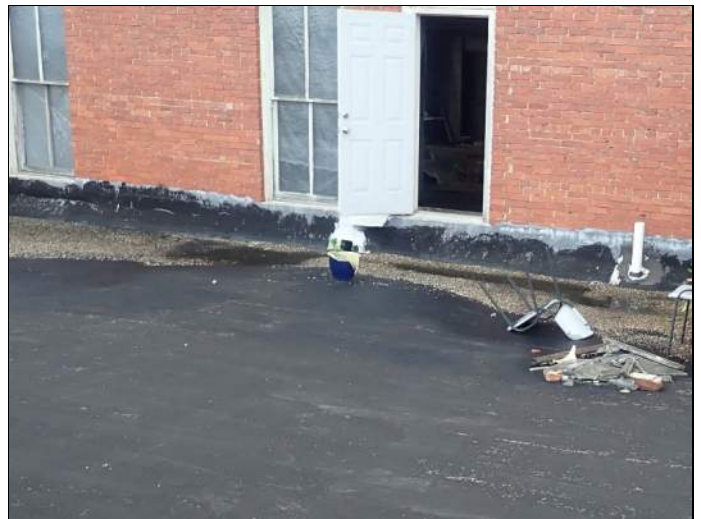
Single scupper at base of upper story wall

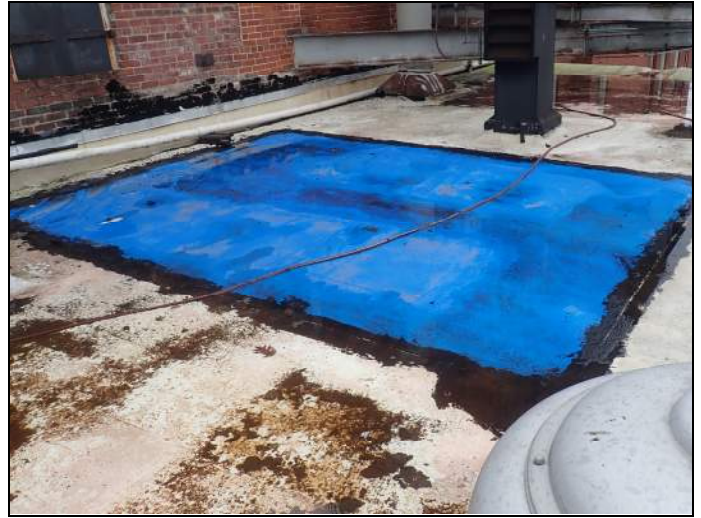
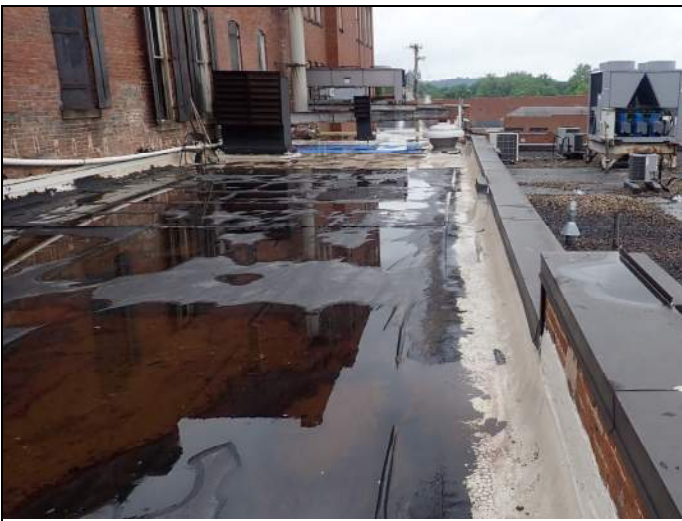
- Several large patched repairs above leaks below.
- Metal flashing had come loose from behind metal coping along a portion of a parapet.

Large patch repair

- Remove and replace the thermoplastic roofing and reinstall flashing as needed.

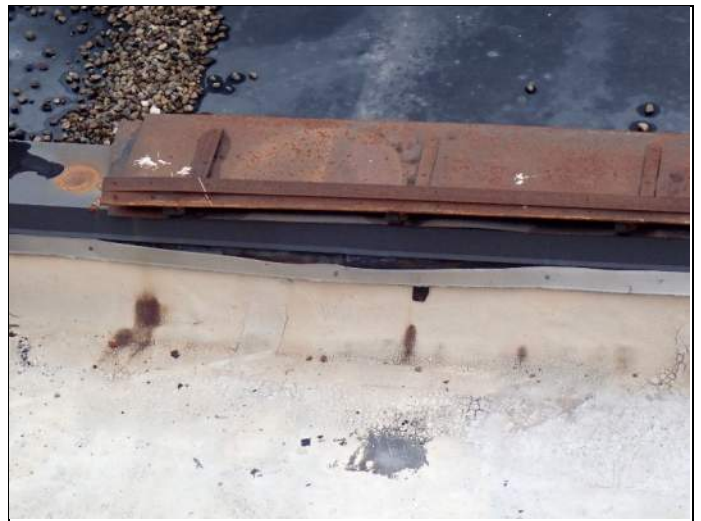
Loose metal flashing

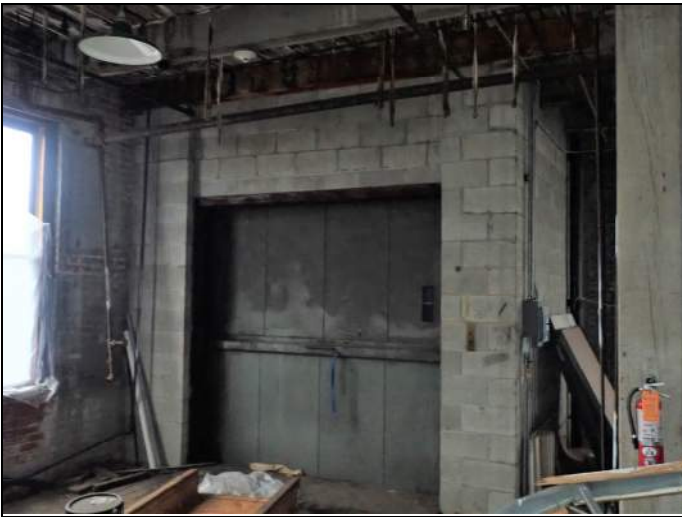
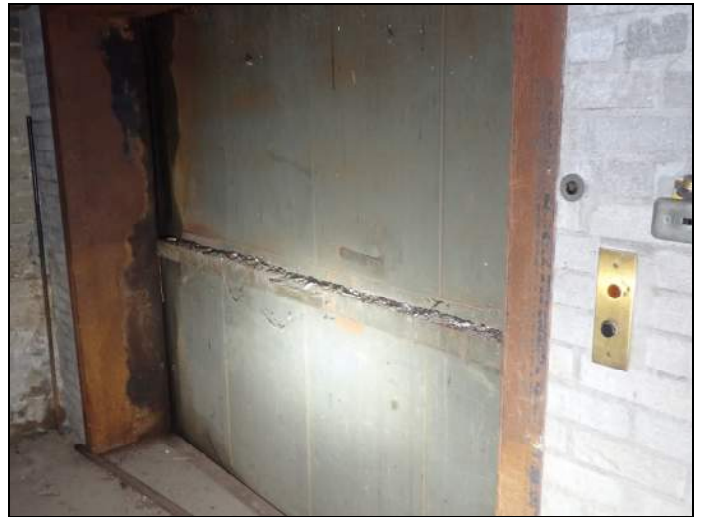
- The elevator room for the service elevator could not be accessed during the assessment. Based on permit information obtained from the Ohio Elevator database, the elevator was removed from service when an annual inspection could not be performed. Repairs or replacements may be needed to bring the elevator back into service.

Service elevator at an upper story

Service elevator in the basement

1. Inspect both elevators to determine necessary repairs and upgrades. Costs for repair or replacement can be determined after inspection.
2. No accessible access is provided to stories five or six. Extending the main passenger elevator or replacing the service elevator may be desired to provide accessibility to the upper stories. This option requires consultation with an elevator contractor to evaluate the existing equipment, and no costs are provided for this recommendation.
3. Replace the current staircase in the west portion of the building to meet current standards.

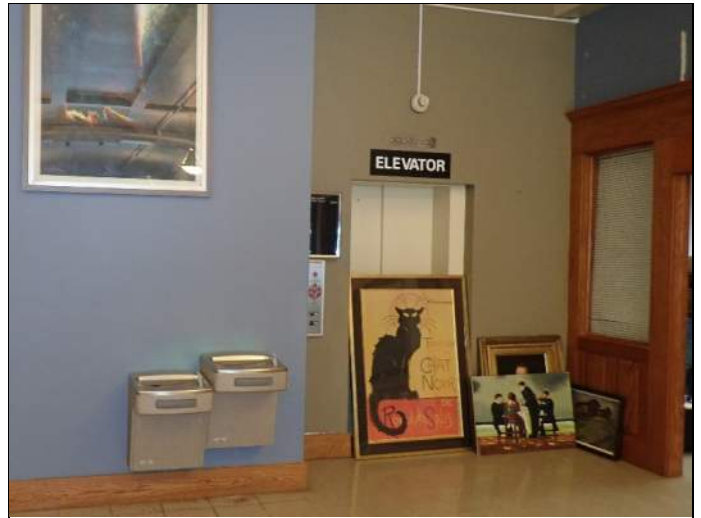
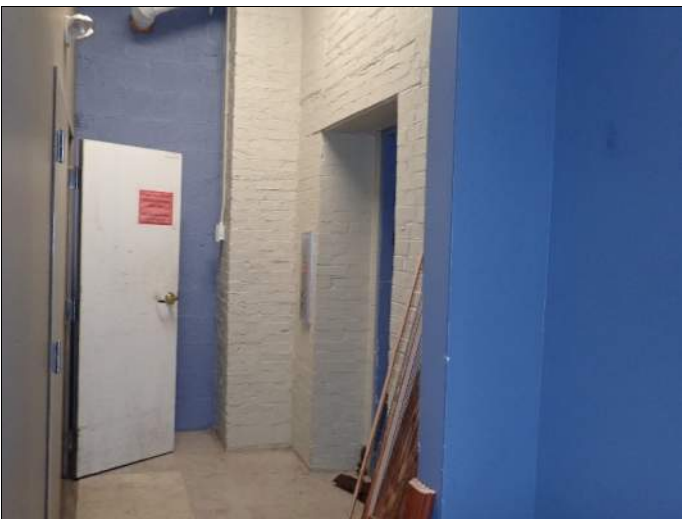
- The passenger elevator was last inspected in December 2014, as indicated on a sticker on the motor; however, it was unclear if the elevator was operational. Based on permit information obtained from the Ohio Elevator database, the elevator was removed from service when annual inspections could not be performed. Repairs or replacements may be needed to bring the elevator back into service.

Main elevator in lobby

Main elevator at elevated first story

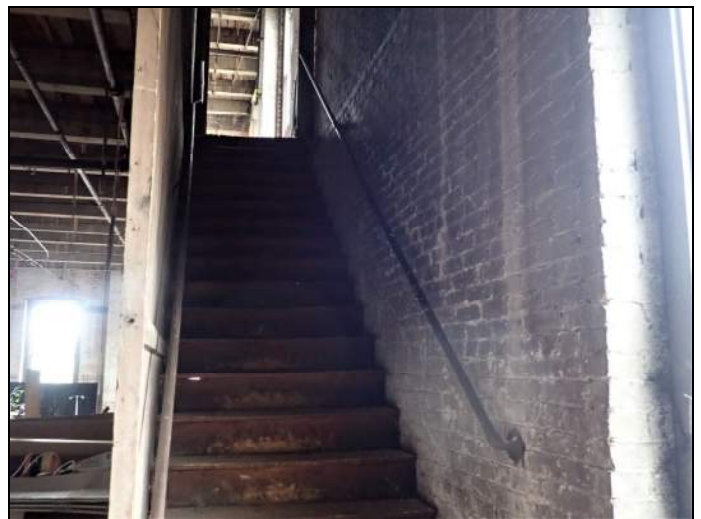
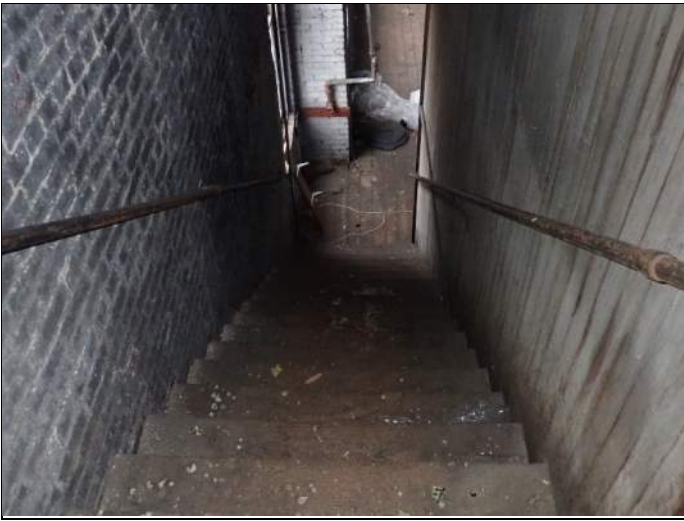
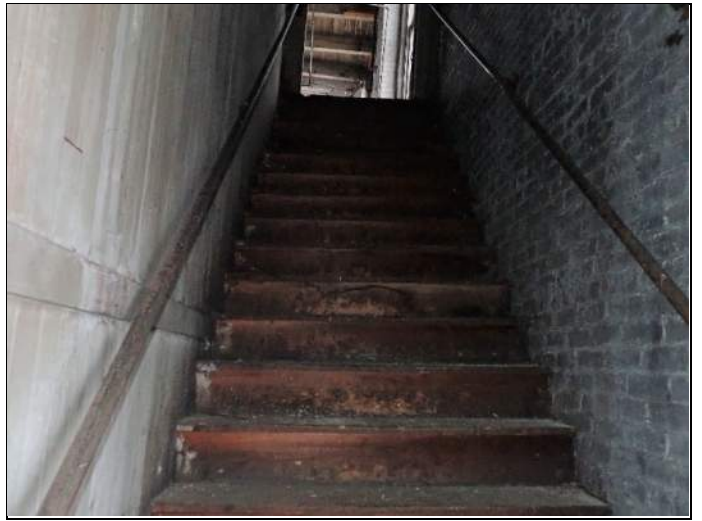
- Stories five and six are not ADA accessible.
- The staircase in the west portion of the building is narrow, in poor condition, and does not meet current dimensional requirements.

Typical wood stairs
