**RE:** **RISE Ohio Project Proposal: 21 to 45 West Columbus Street Building Evaluation**

# JSR RENTALS, LLC BUILDING EVALUATION

21 to 45 West Columbus Street, Nelsonville, Ohio  
American Structurepoint Project No. 202200371, Phase 1200  
March 10, 2023

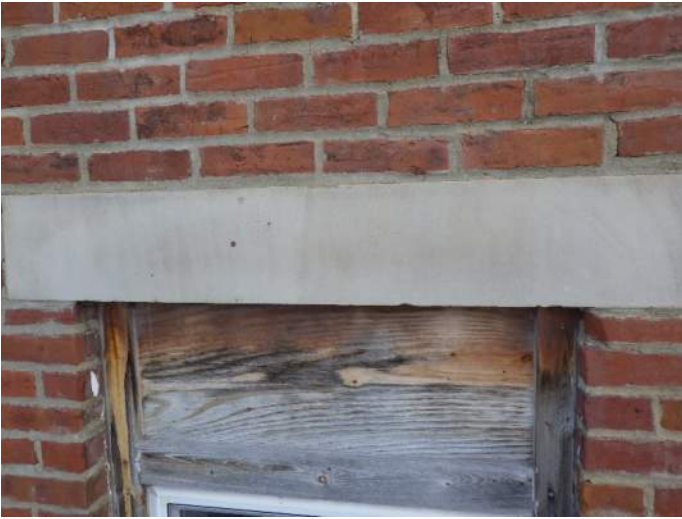
- The paint on the surface of the steel headers above the storefronts was peeling and flaking throughout.
- The stone lintels above the building's windows were in good condition, exhibiting light staining throughout.

Typical stone lintel above window

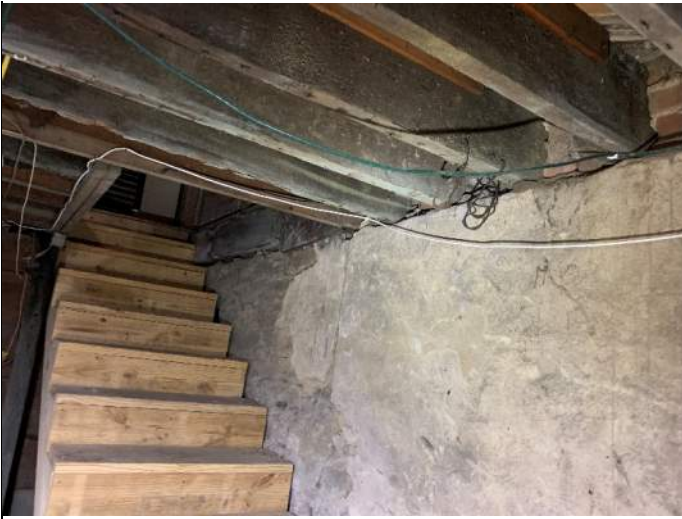
Typical stone masonry wall with plaster coating

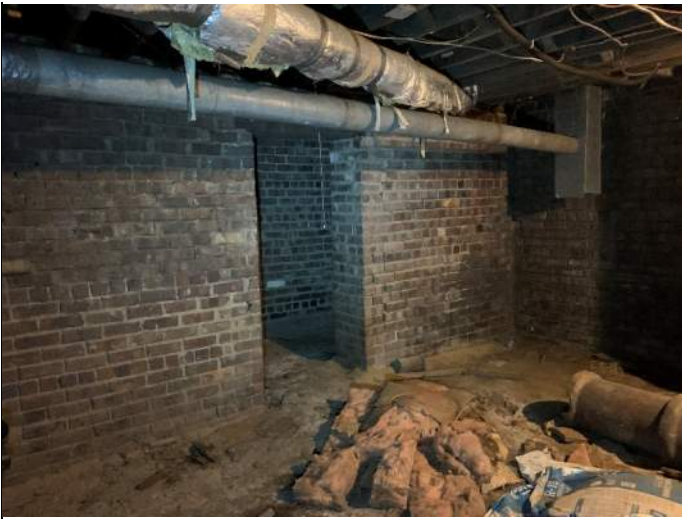
Typical brick masonry wall

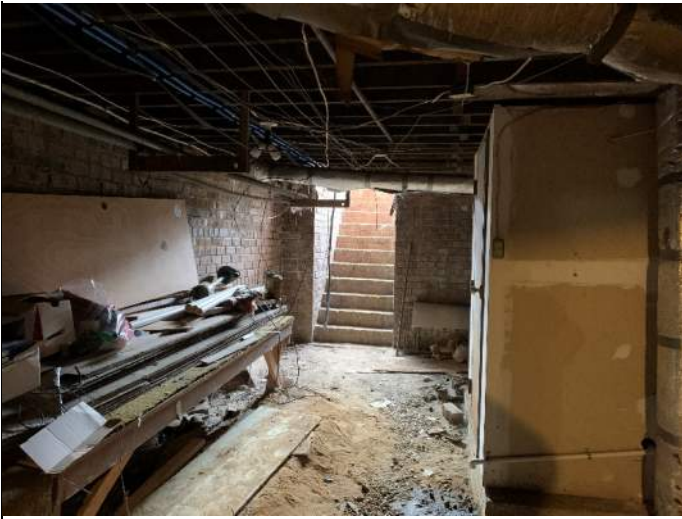
Typical "dirt" floor

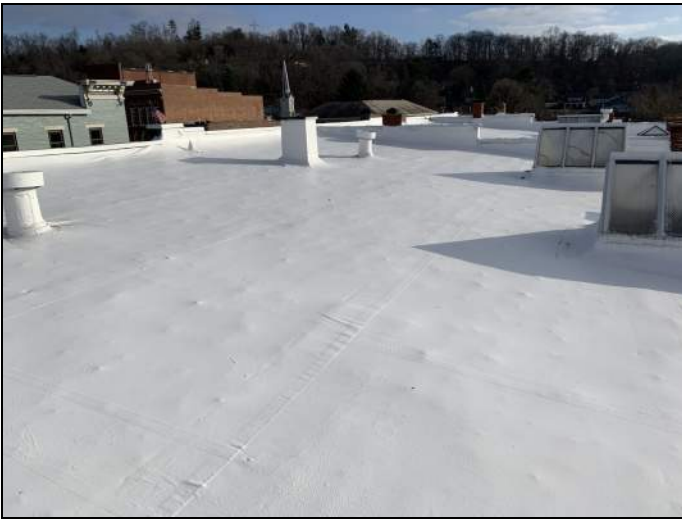
Overview of roof looking northeast

- Provide proper termination along the edges of the membrane roofing, including new flashing and termination bars.
- Cover open chimneys and replace deteriorated chimney crowns to prevent water infiltration.
- Install new vent hoods where they are missing.
- Replacing sealant may reduce water intrusion as a short term and ongoing repair; however, replacing deteriorated skylights is recommended to prevent long-term water intrusion.

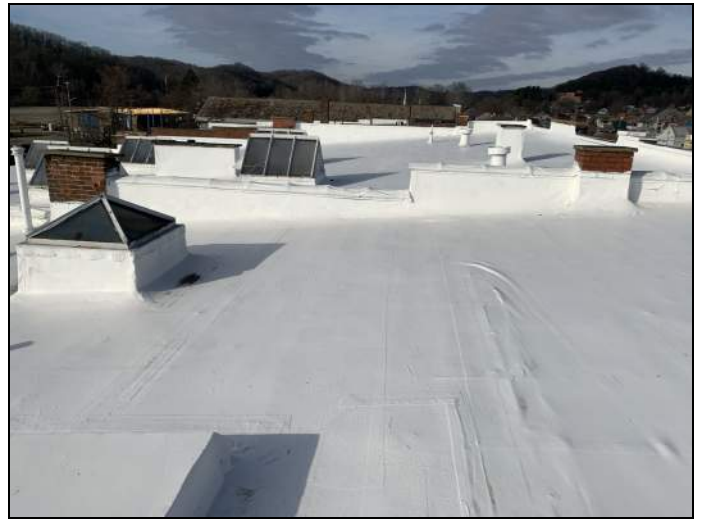
Overview of roof looking west

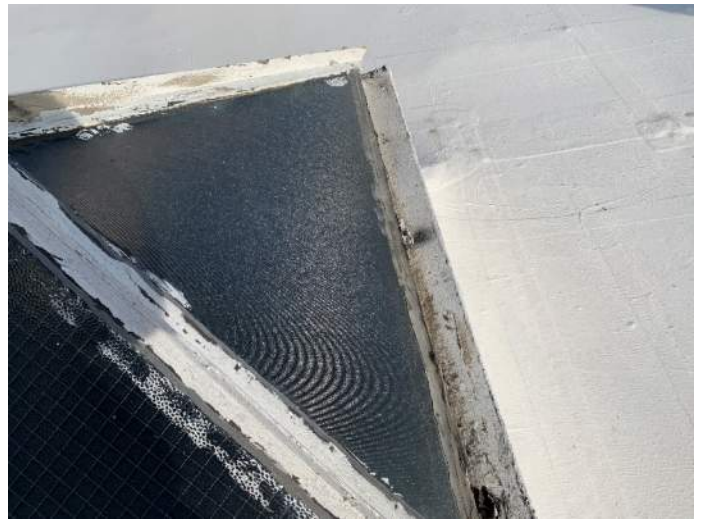
Condition of skylight

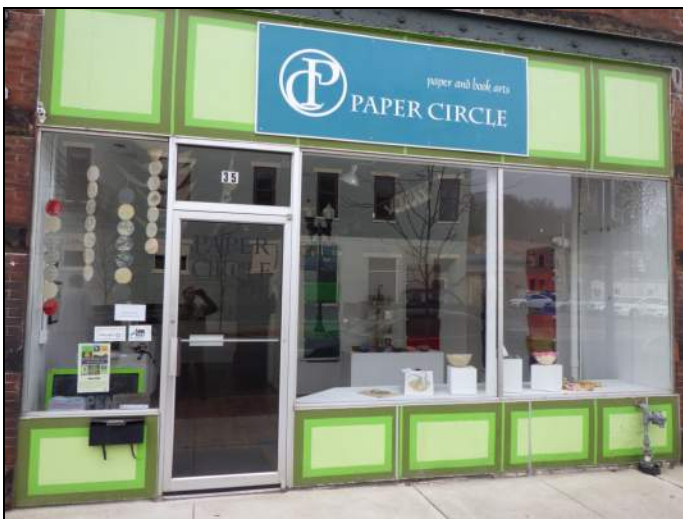
Typical first story front entrance

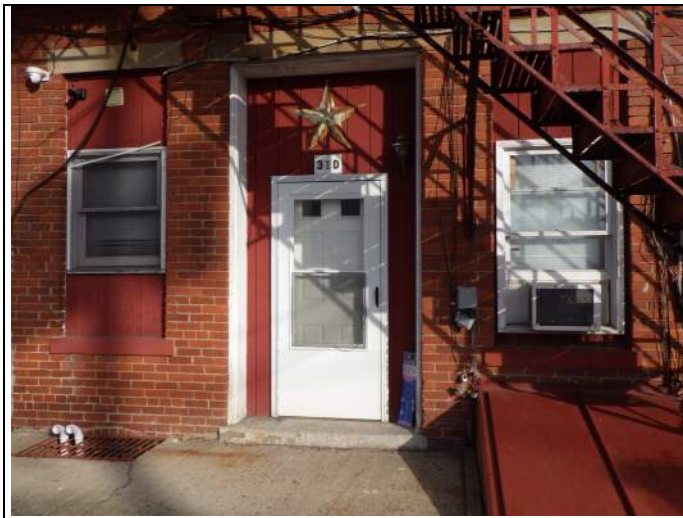
Typical first story rear entrance

- Provide ADA accessible ramps at the rear first story entrances.
