**RE:** **RISE Ohio Project Proposal: 21 to 45 West Columbus Street Building Evaluation**

# JSR RENTALS, LLC BUILDING EVALUATION

21 to 45 West Columbus Street, Nelsonville, Ohio  
American Structurepoint Project No. 202200371, Phase 1200  
March 10, 2023

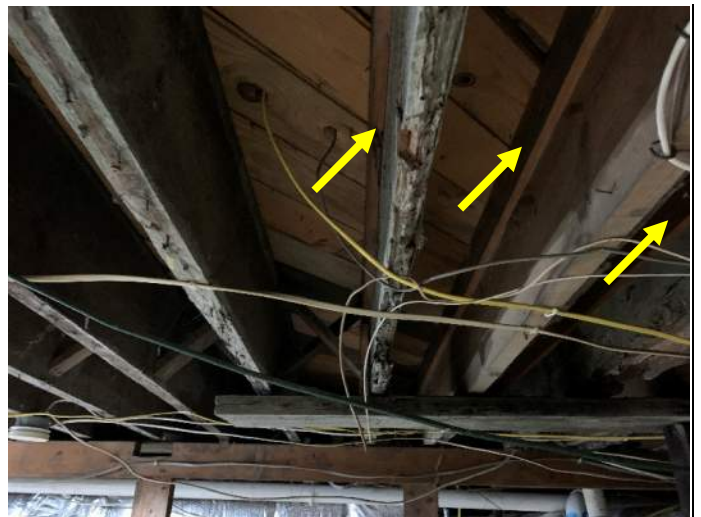
Typical floor joists supported by stone masonry

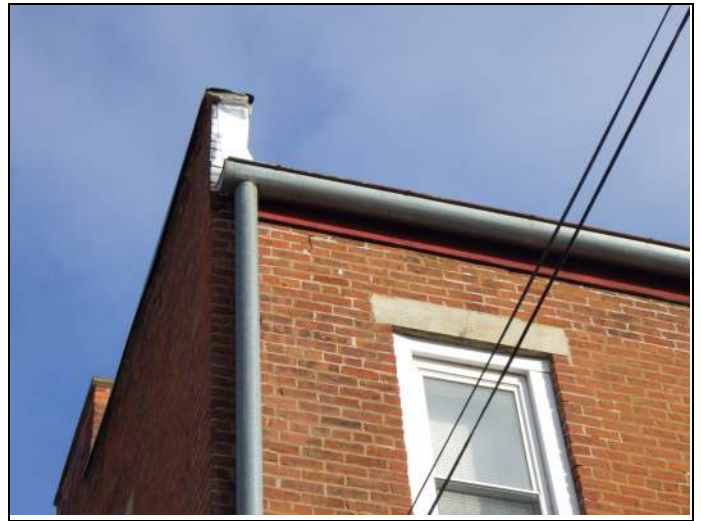
Gutter and downspout along south roof edge
